YEG-Article-12/2025

# Geotechnical Failures of Pavement Structures in Abakaliki, Southeastern Nigeria

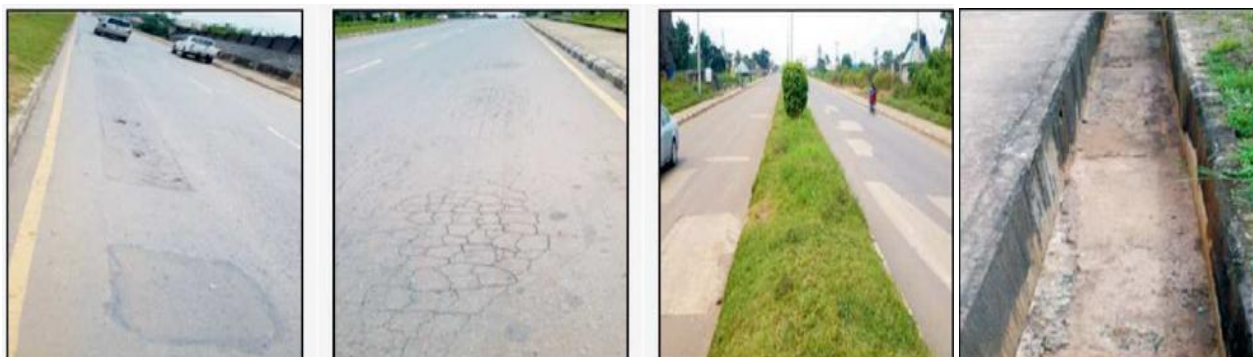
Drainage infrastructure also played a critical role. Although U-shaped concrete drains (Fig.2) were installed, some medians were porous and unlined, allowing water infiltration. This led to subgrade saturation and swelling of the clay-rich soils, reducing the pavement's bearing capacity. The combination of high plasticity soils, inadequate sub-base thickness, and poor drainage explains the recurrence of rutting and alligator cracking in specific locations.

Figure 2 The Enugu - Abakaliki Road with potholes, ruts, alligator cracking, fatigue concrete & U-Shaped concrete drains (Source: Babadiya & Igwe 2021)
