The 2023 Jajarkot Earthquake, Nepal– First Situation Report

Dr. Ranjan Kumar Dahal

President, Nepalese Society of Engineering Geologists (NSEG)

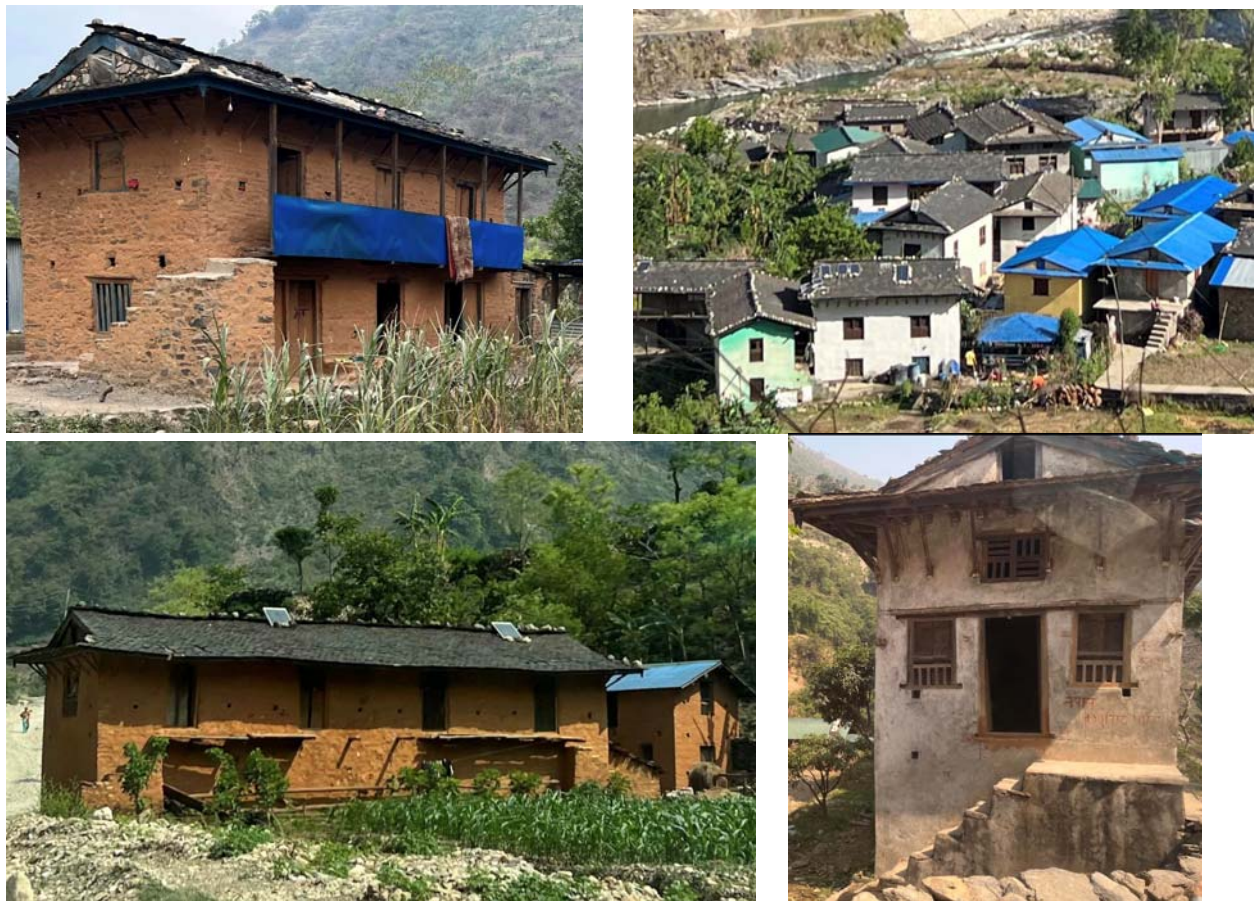
While the 2023 Jajarkot Earthquake might not be considered significant in terms of its magnitude and area coverage, it resulted in a high death toll in the Jajarkot and Rukum Pashchim districts. This was primarily due to the timing of the earthquake, occurring at midnight when most people were asleep, and the prevalence of old non-engineered mud and mortar buildings, as depicted in Figure 4. The extent of

Figure 4, Rural buildings in Barekot and Nalgad municipalities of Jajarkot district (Photographs taken in June 2023)

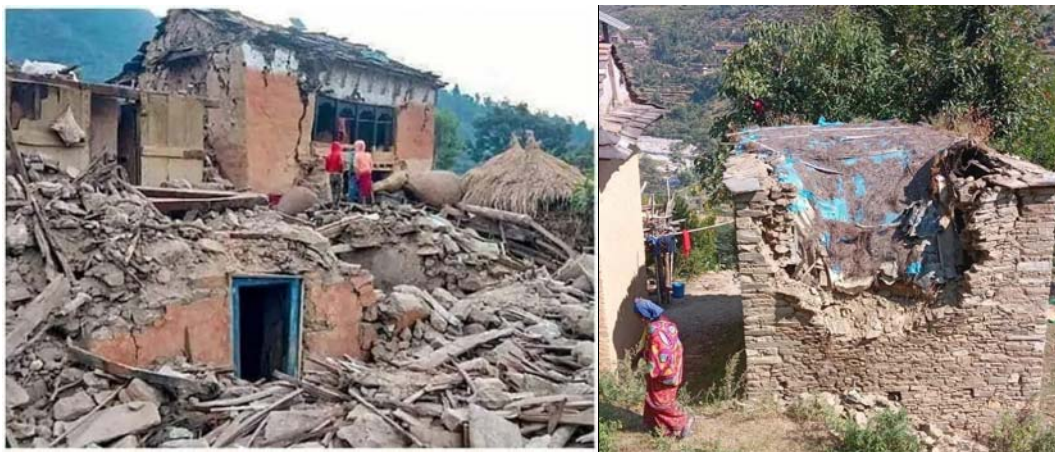
the damage to these mud mortar buildings following the earthquakes is portrayed in Figure 5. Common damages to these rural buildings following the earthquake typically include structural cracks, wall collapses, roof damage, and complete collapse (Figure 6). These buildings experienced the destruction of mud and mortar walls, as well as the collapse of weak or poorly constructed roofs. Additionally, most of these non-engineered buildings were partially or completely collapsed, leading to significant structural instability and potential risks for local people.

Figure 5, Typical rural building damages after the earthquake (Photo: Manju Joshi)

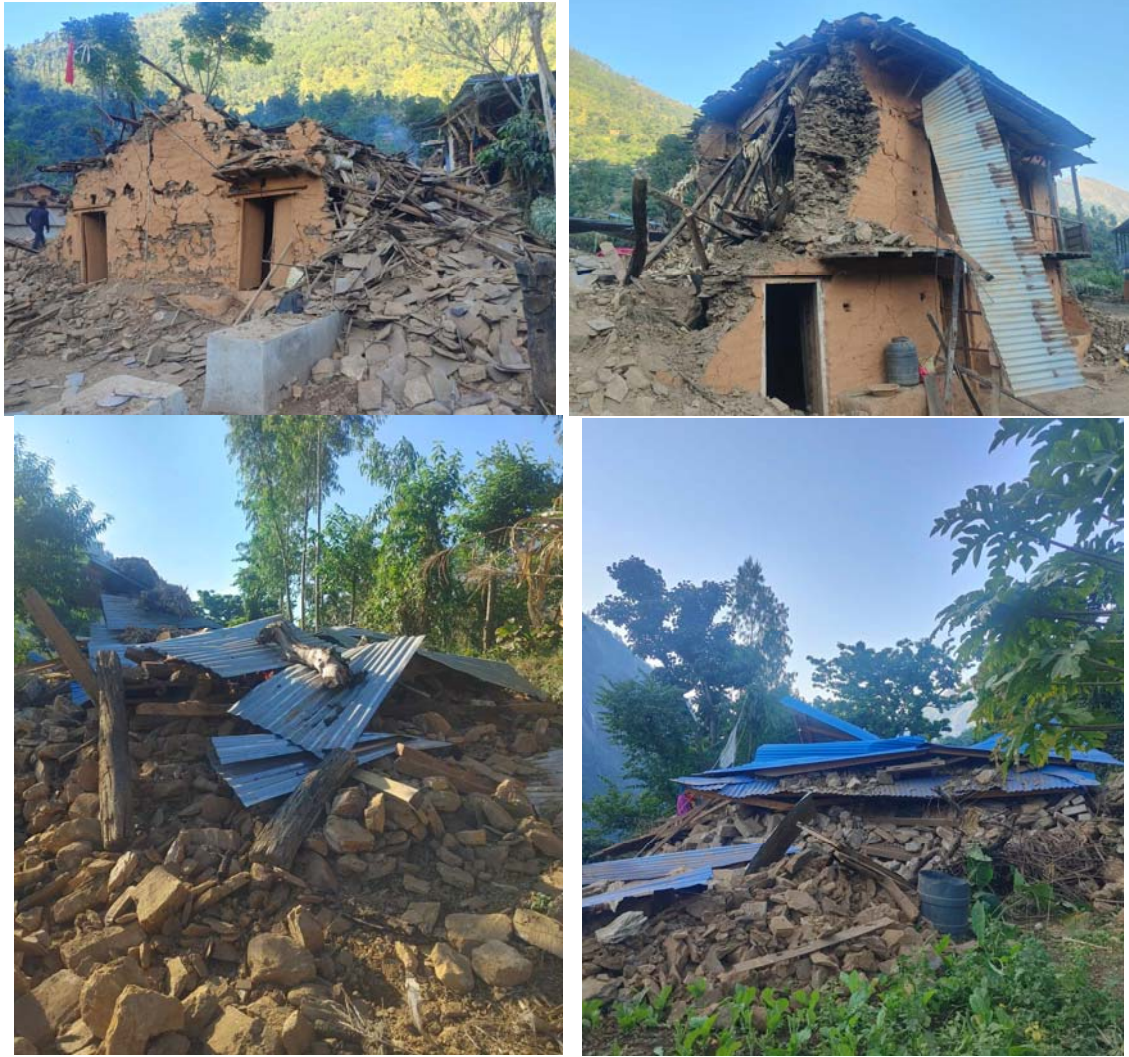
*Figure 6, Typically damage pattern of mud mortar type buildings in Nalgad Municipality, Jajarkot district
(Photo: Dr. Lok Bijaya Adhikari)*

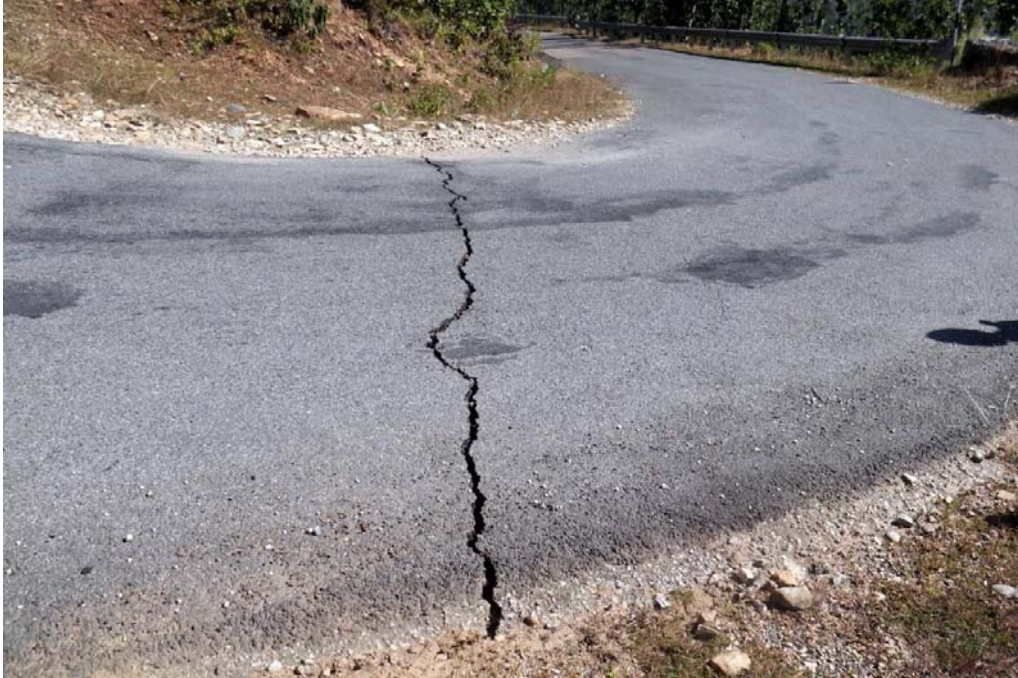
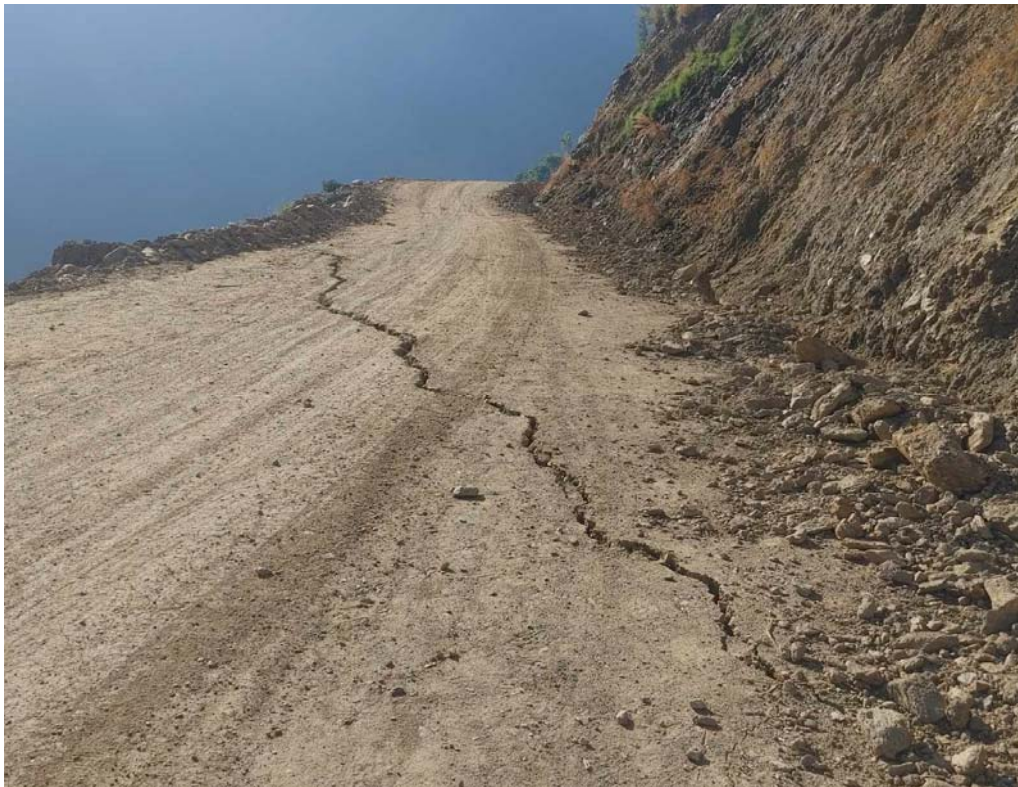
The earthquake had an impact on a total of 213 school buildings. Among these, 91 schools were completely destroyed, while 122 schools suffered partial damage (Dp-Net, 2023). Additionally, the Jajarkot Earthquake caused a rupture in many area of the Chinchu-Jajarkot Road (Figure 7). A few landslides were also triggered after the earthquake and blocked the road for two days (Figure 8).

Figure 7, Typical cracks on road after the earthquake (source of top photo: RSS, Nepal and bottom photo: Dr. Lok Bijaya Adhikari)

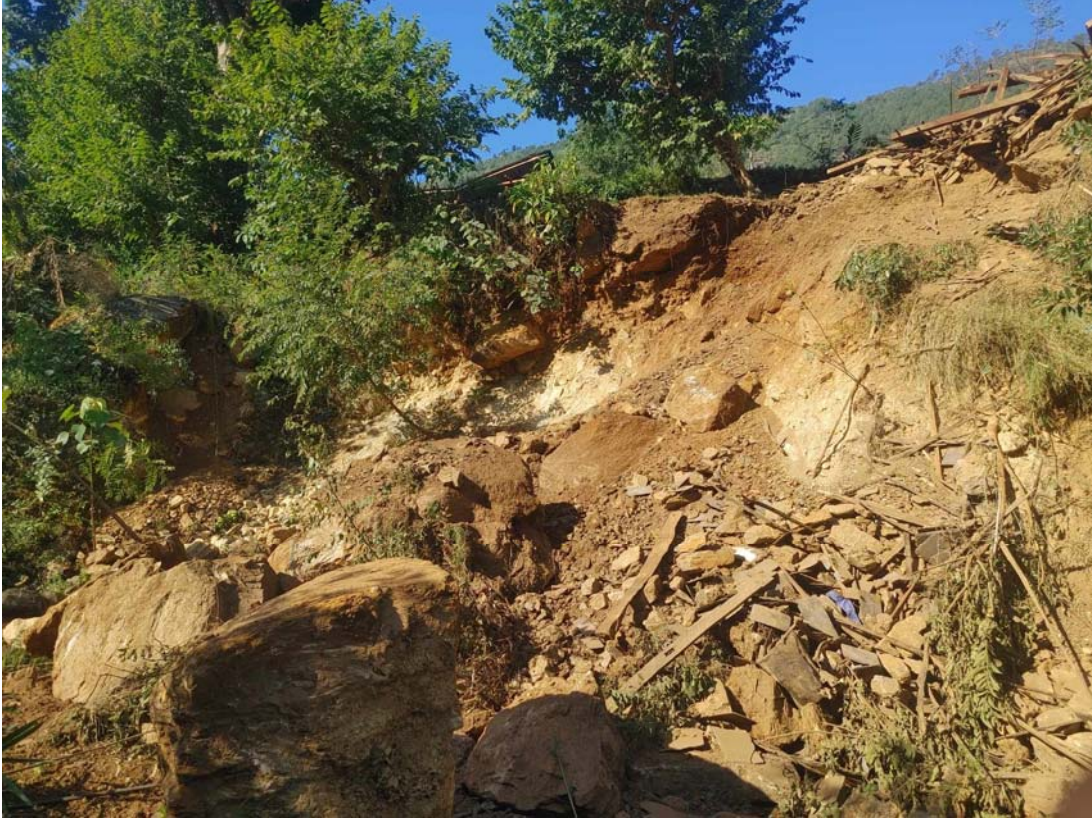
Figure 8, Landslide triggered by Jajarkot Earthquake, Nalgad Municipality
