## QUANTIFYING URBAN DAMAGE DUE TO SLOW-MOVING LANDSLIDES: A MULTI-INSTRUMENT AND MULTI-DISCIPLINARY APPROACH

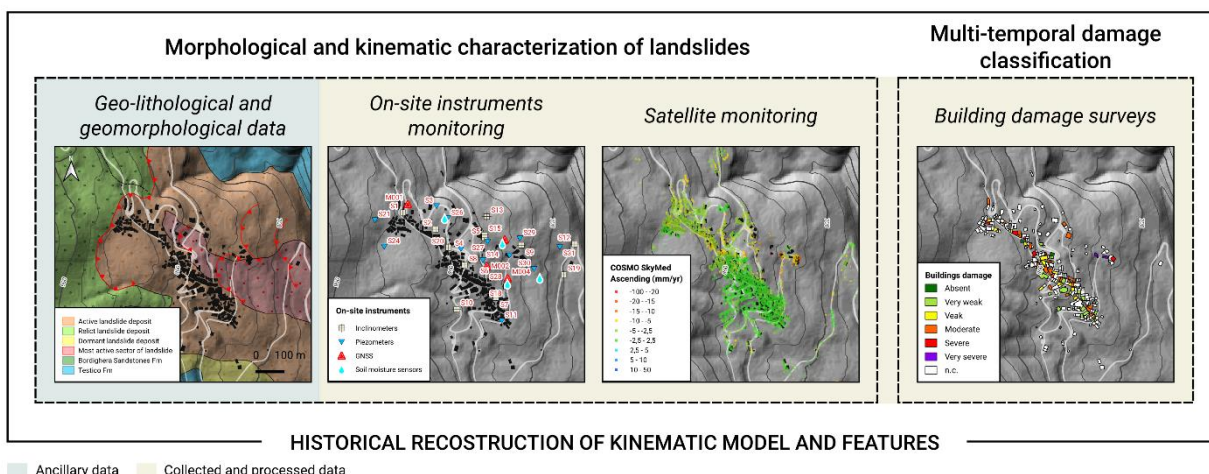
The proposed methodology consists of a multi-instrument and multi-disciplinary approach that merges geological-geomorphological ancillary data, on-site instruments measurements, satellite monitoring and building damage survey to improve the comprehension of the relation between the morphology and kinematics of landslides and the induced effects on the built-up environment (Figure 1).

**Figure 1.** Outline of the materials and methodology used.

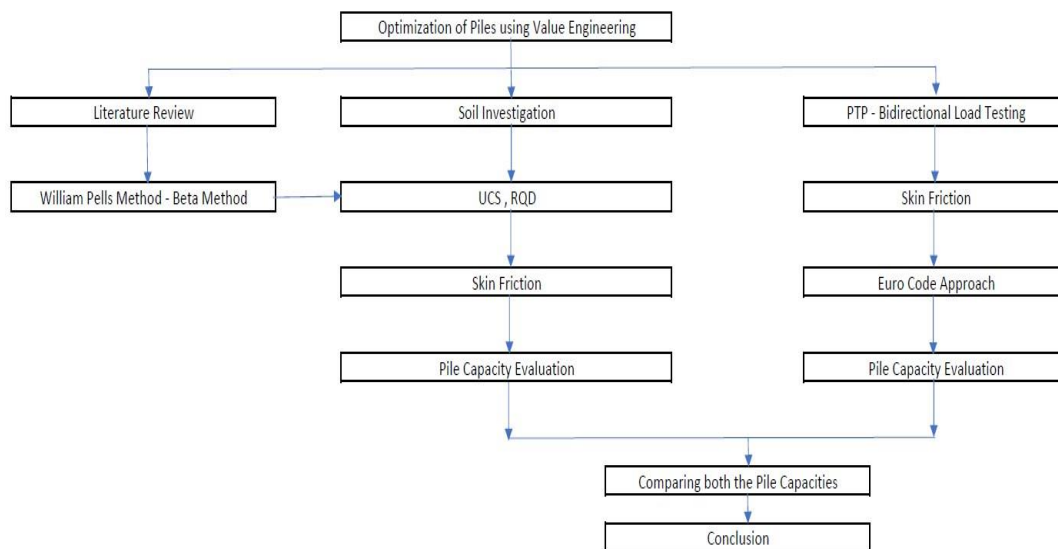
As per Dubai building code (DBC) 2021 requirement, for obtaining allowable working capacity of pile based on site investigation data a global safety factor of not less than 2.5 needs to be considered, however in case of verification by static load test on piles are performed then partial safety factors as per Eurocode to be applied. Accordingly, in order to estimate insitu skin friction in weak rocks, 3 high-capacity bidirectional load tests were performed. The value engineering exercise was carried out, using Eurocode approach, through back analysis of the data to optimize the design lengths of the piles. The theoretical pile capacity was estimated based on William and Pell’s method (ref. 5) was found to be 8900kN for a length of 30m. It was anticipated that a minimum a reduction +20% in pile length was considered.

**Figure 1.** Methodology adopted for value engineering

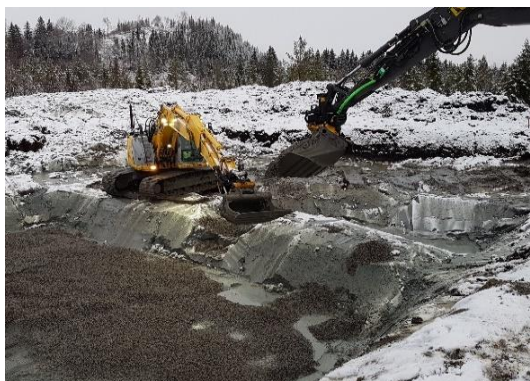
**Figure 1.** Two excavators spreading crushed stone into the excavation pit

was expected. Accordingly, two foundation methods were tested: 1) soil improvement by compacting crushed stone in layers and construction of foundations according to the original design. Method was chosen at tower sites excavated earlier and according to the design (four separate excavation pits for each foundation) as the material seemed relatively stiff, and 2) at later excavated tower sites, change in foundation geometry was chosen. Instead of four separate and deep foundations, one big and shallower foundation foot plate was applied, with geonet and layer of uncompacted crushed stone beneath the foundation (Figure 1). Method 1) was partially successful. Compacting crushed stone made the material softer at some spots so it wasn't compacted evenly. Most

of foundations built with this method had differential settlements but inside tolerances. Foundations at one tower spot built with this method had to be demolished and rebuilt due to differential settlements caused by heavy rain during concreting. Method 2) was successful at all applied tower spots. At one tower spot material was so soft that people were sinking in it so rapidly that it wasn't possible to work in it. At this tower site foundation piles were applied. Figure 1 shows laboratory and in situ test results conducted at this tower site.

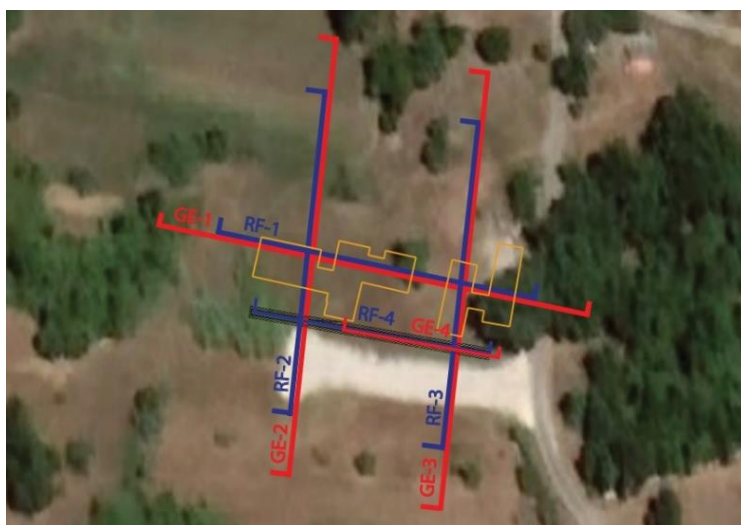
Figure 1. Distribution of geophysical profiles.

Geophysical profiles were set along main axes of the building, perpendicular to flysch and limestone contact and along all locations with presumed fractures and caves. Geophysical methods included seismic refraction tomography and geoelectric tomography. Combination of such methods provides key parameters needed to differentiate materials and to detect fractured zones with positions of main fractures and caverns (Gebrande & Miller, 1985.) (Gibson, Odegard, & Sutton, 1979).

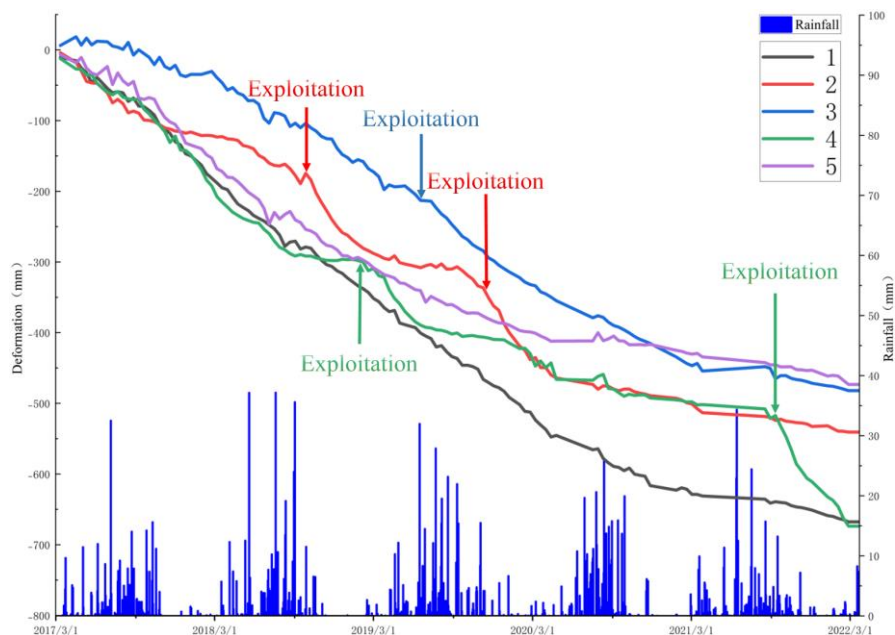
The subsidence rate in these areas is negative, exhibiting a pattern of multi-layered circular nesting. According to the timing analysis results, subsidence in the goaf areas occurs continuously. The subsidence rate is significantly influenced by mining activities, leading to a sharp increase in settlement rates.

**Figure 2.** Deformation results from the time series curve of characteristic points in the subsidence zone

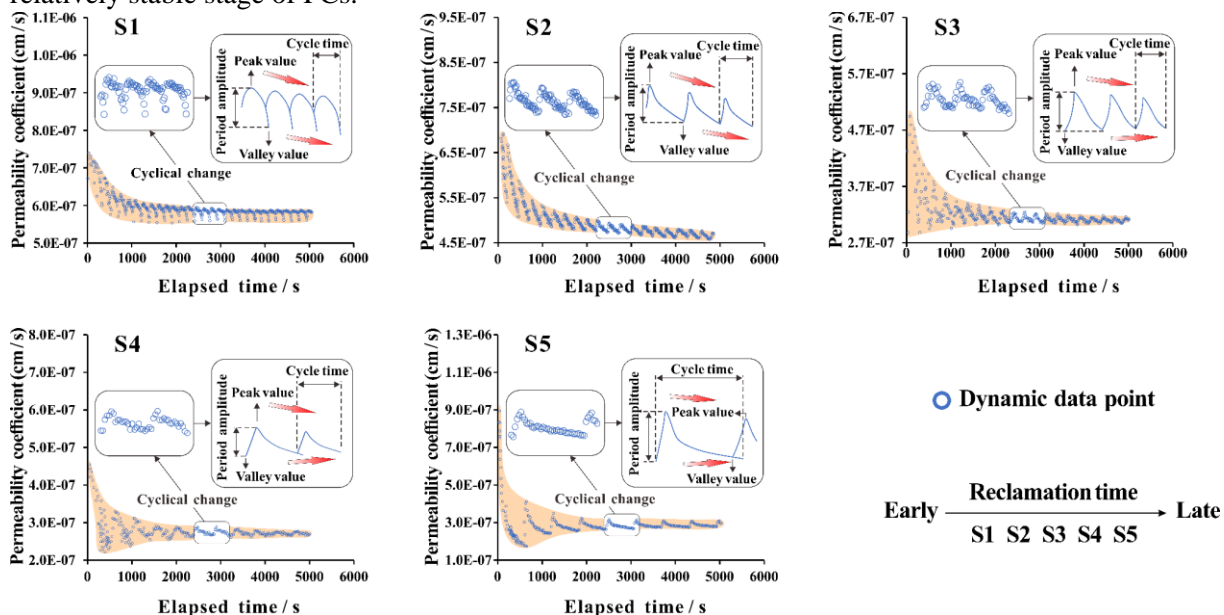
The results revealed that the seepage process of clay showed a transition from unstable seepage to relatively stable seepage. Meanwhile, the permeability coefficient (PC) attenuated with time cyclically, indicating the alternating effect of the closed and opened unstable seepage channels. During seepage, clay particles could be entrained by pore water and intercepted by pores, thus clogging seepage channels. Then, the increased pore water pressure could break through new seepage channels. The degree of pore clogging was positively correlated with the average cycle period of PCs, and this was also present in the relatively stable stage of PCs.

**Figure 1.** Evolution and statistics (per 1000 s) of representative permeability coefficients of soil samples S1-S5.

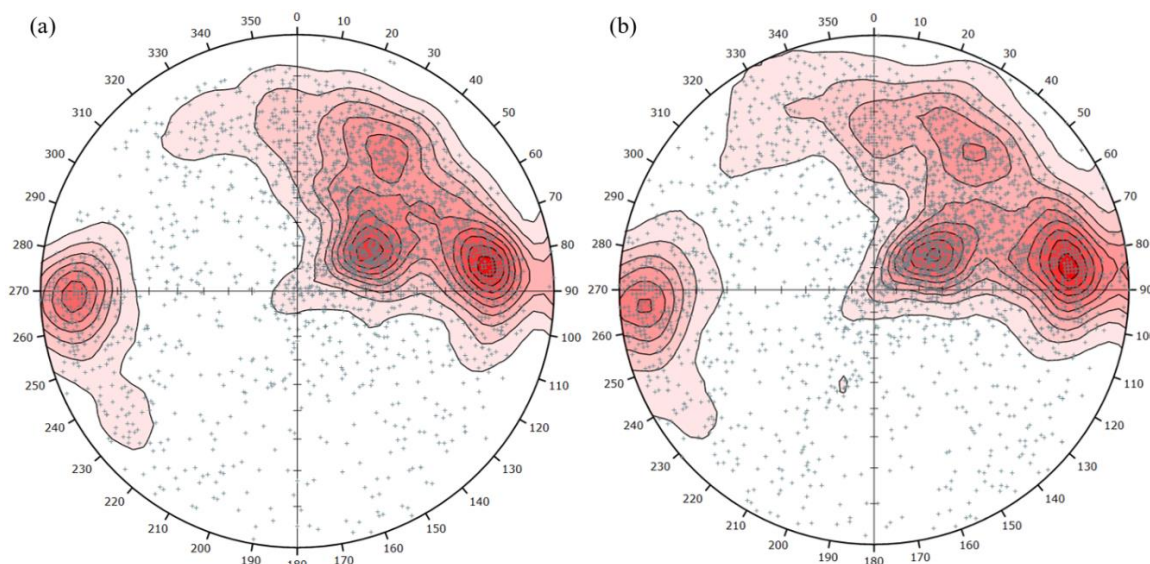
The edge-first connection algorithm was applied to identify discontinuities on the Xulong slope located in the Jinsha River suture zone. The slope, measuring 280 meters in length and 200 meters in height, comprises a point cloud with 13 million points. The algorithm efficiently identified 2780 discontinuities on the slope within just 3 hours, demonstrating excellent recognition efficiency. A comparison between the discontinuities identified by the automatic method and those identified manually on the model revealed that the pole plots from both methods had highly similar pole distributions and high-density centres (Figure 1). Furthermore, both methods identified three dominant groups of discontinuities, with their orientations shown in Table 1. The differences in orientations between the dominant groups identified by the two methods ranged from  $2^\circ$  to  $8^\circ$ . This result demonstrates that the edge-first connection algorithm also delivers highly satisfactory accuracy in recognizing complex fractures over large areas.

**Figure 1.** The comparison of pole charts from automatic method (a) and manual method (b).
