YEG-Article-2-06/2024

Recurrent Road Collapse Problem in Kapasia-Sreepur Link Road of Gazipur District, Bangladesh: Consideration of Quaternary Geology, Geomorphology, and Clay Mineralogy for Risk Assessment

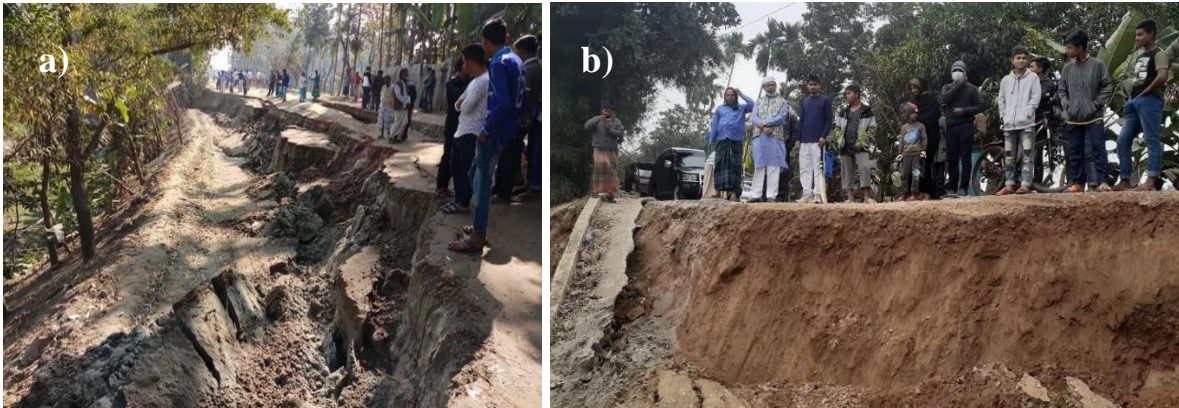
Figure 1 a) (Photo credit: The Daily Asian Age) Road collapse between Kapasia-Sreepur on 13 February 2018, b) (Photo credit: The Dhaka Tribune) Part of the Kapasia-Sreepur road collapsed in Kapasia Upazila of Gazipur District, December 11, 2020.

In addition, at least 760 m of land (Figure 1b), affecting a part of the road connecting Kapasia and Sreepur and adjacent areas, collapsed into the Banar River in Gazipur on 10 December 2020 at 2 am (The Dhaka Tribune, 11 December 2020). The same area collapsed previously in February 1964 and February 2003. Mr. Saif Uddin, the Executive Engineer of the Local Government Engineering Department (LGED) in Gazipur said: "Development works of the Sreepur-Kapasia road were completed last year. We have not estimated any risk of collapse during the six-month monitoring period of the road" (The Dhaka Tribune, 11 December 2020). Prior fieldwork experiences and sample analysis results guided an alternative way to re-think the root cause of the problem. Quaternary geology, geomorphology, and clay mineralogy have been considered as the broad parameters to delineate the road collapse risk assessment.

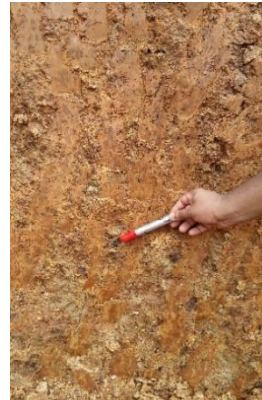
Figure 3 Iron-manganese concretions in deeply weathered Madhupur Clay

During the field investigation, cracks and fissures have also been recorded in local earthen houses (made up of Madhupur clay), iron-manganese concretions (Figure 3), and bluish-gray silty clay (Figure 4). Samples have been collected from the cracked surfaces surroundings and X-ray diffractogram (XRD) (clay mineral analysis), X-ray Fluorescence (XRF) (elemental composition), and Field Emission Scanning Electron Microscope (FESEM) (imaging and mineral mapping) have been carried out.
