# **Engineering Geology & Geotechnics:** Building for the Future

### **Proceedings of the 4th European Regional Conference of IAEG**

Dubrovnik, Croatia, 8-12 October 2024

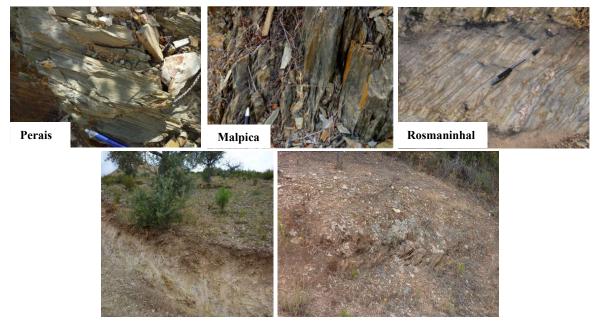
Figure 3. General features of the three geological formations identified and of the surficial soils. The thin surface soil is composed of poor quality highly weathered rock, silt, and clay.

and shows close to very close joints (F4-F5). Foliation, the main anisotropic feature of the rock mass, defines very small blocks that tend to produce localized rock fall and toppling. Drill cores obtained for the study of the dam foundation rock mass show that the rocks are dark grey to black in color when sound (W1), and moderately spaced (F3). In the quartz-rich layers, the foliation is not well marked whilst in the phyllite it imprints a strong anisotropy to the rock. The surficial soil forms a thin layer mainly composed of clay. Figure 3 presents the main aspects of the three formations and the surficial soil.

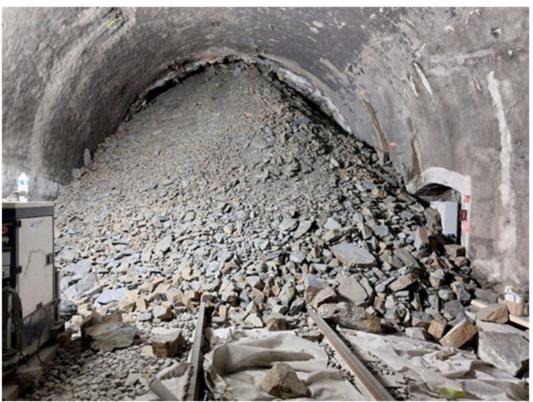
Figure 1. Rock slump seen from the southern part of the tunnel

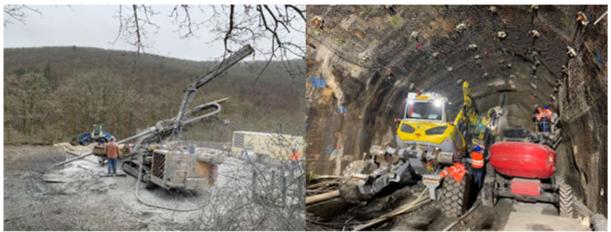
Figure 8. On the left: drilling from above ton inject the grout. On the right: drilling from the tunnel for anchoring the deconsolidated soil injected above the hole in the vault

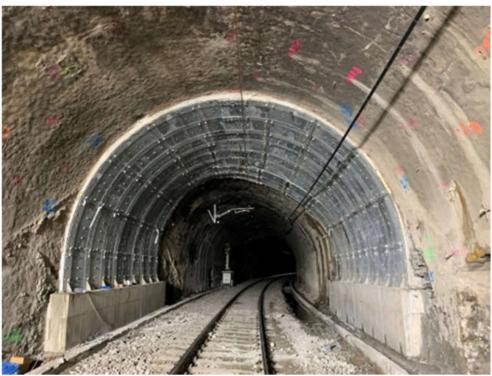
Figure 9. Situation at the end of the safety works (same point of view as Figure 1)

Figure 9 shows the situation at the end of the safety works, with the final belts in place.

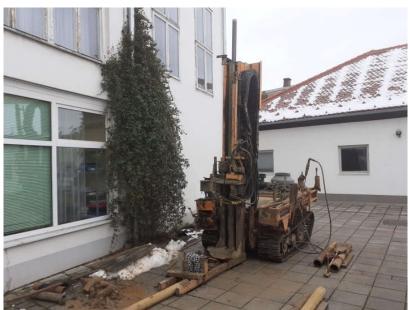
Figure 2. Location of borehole B-3 with Geotech 605D drill rig.

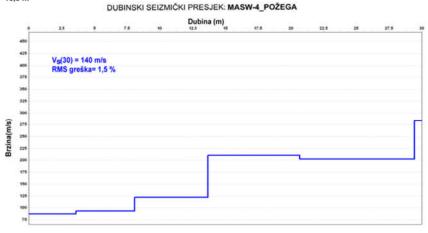
## Figure 8. MASW profile MASW-4\_Požega

METODA : VIŠEKANALNA ANALIZA POVRŠINSKIH VALOVA (MASW) RAZMAK GEOFONA: 3,0 m OFFSET= -15,0 m

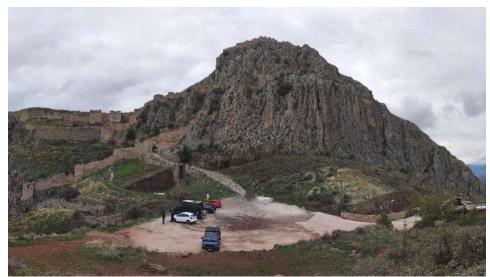
Figure 6. Panoramic view of the Acrocorinth cliff in which the 3d terrain model was created

In the Acrocorinth cliff the three systems of discontinuities, as examined before, are the main factor in potential failures, with overturns and falls of rectangular pieces of small-medium size that can reach a size of 1-1.3 m<sup>3</sup>. For this reason, the 3d terrain model that was created was particularly useful to simulate rockfalls in the entire research area (Fig 6).

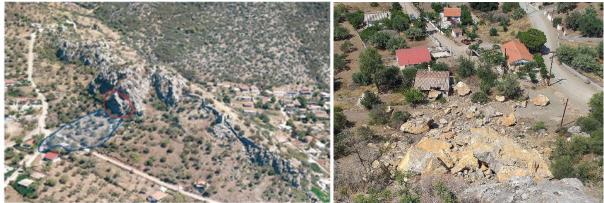
Figure 1. Left: An aerial photograph showing the location of the 2019 rockfall detachment (marked in red color) and the area of rock blocks deposition (marked in blue color); Right: A photograph of the rockfall event retrieved from the crest of the slope.

In 2019, a rockfall event occurred after heavy rainfall and affected a house located at the base of the slope putting also into risk the integrity of the archaeological site. Site investigation proved that there have been more rockfall incidents formerly. Therefore, it is estimated that if stabilization measures are not applied, it is very likely that a potential rockfall may impact the area down slope, especially in the event of a heavy rainfall or an earthquake.

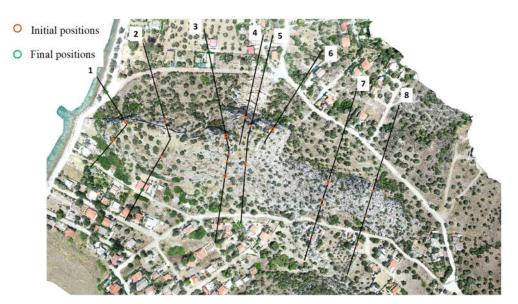
Figure 4 Trajectories (initial and final positions) of the rock blocks simulated in the 2D analyses.

The results of the 2D rockfall analyses prove that the region in the vicinity of the promontory is characterized as high risk with regard to rockfall impact. In most cases, the rockfall trajectories reach the houses situated at the toe of the slope. In Figure 3, the orange circles mark the initial position of the rock blocks and the green ones their final position along each cross-section. The north-eastern part (cross-sections 7 and 8) is less affected since the width of the promontory is reduced and the length between the settlement and the promontory is high enough for the rock blocks to stop. Figure 4 illustrates two characteristic examples of rock fall trajectories along cross-sections 1-1 and 6-6.

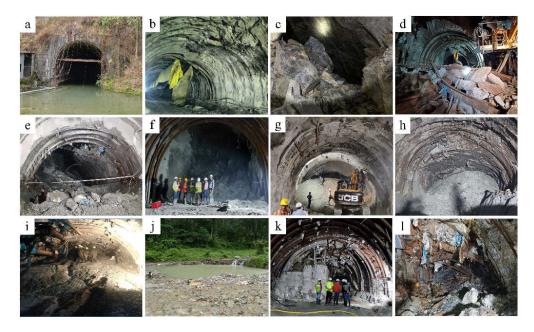
**Figure 3.** Showing Photographs of Hindrances faced during resumption of Underground works. (a) Water accumulation at Tunnels. (b) Twisting and Buckling in Lattice girder. (c) & (d) Rockfall and cavity formation in allready excavated tunnel portion (e), (f), (g) & (h) huge cavities and collapsed tunnel area in allready excavated tunnel portion. (i) & (j) Collapsed tunnel face and surface cave-in above the tunnel at Kalej Khola (k) & (i) Collapsed tunnel below Kamlet Khola.

- The already excavated tunnel behind HRT Face 4A and 4B from Adit-3 were collapsed due to encounterance of highly weathered and sheared Phyllite. Further, the reported incidence of a surface cave-in had compelled fear among the local public. Also, downstream Faces 5A & 5B of HRTs from this Adit had encountered a maximum number of collapses/cavities formations at various locations especially where Steel rib support was not provided.

- From Adit-4A two faces Face 7A & 7B were already excavated and partial lining work was also completed. But the upstream faces 6A and 6B were partially excavated and Face 6A was in a collapsed state 100m behind the Face.

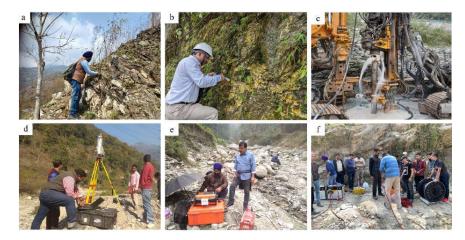
Figure 4. Showing Photographs of Confirmatory Surface Geological and Geophysical studies. (a) Geological survey along HRT alignment. (b) Assessing rock strength using Schmidt Hammer. (c) Drilling activity (d) Topographical survey (e) Resistivity Imaging. (f) Cross hole P-wave Tomography.

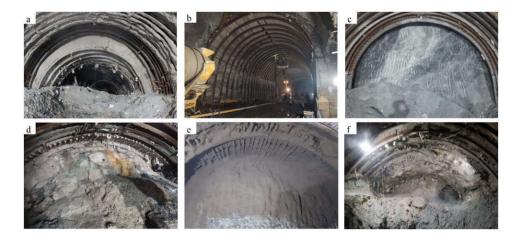
Figure 5. Showing Photographs of rectification works and additional support measures (a) restoration work under progress, skin to skin ribs were embedded under SFRS (b) Rectified tunnel (c) Fore poling to stabilise the crown of the Tunnel. (d) & (e) Pipe roofing created an umbrella-like structure above the crown to prevent collapses. (f) Multisegmental excavation.

During construction by the previous developer, primary support in the form of shotcrete, rock bolts, dominantly Lattice Girder etc. were provided in HRTs / Adits that had the initial support for the opening. Consequently, many stretches of the already excavated HRTs by previous developer had developed with age various defects like chipping out of shotcrete, distressing in rock bolts, buckling of LG / Ribs, distortion of the tunnel cross section which has been associated with huge cavity / cone formation. Accordingly, more than 300 working days have been consumed for additional restoration and strengthening measures for most of the already excavated portion of the HRTs to avoid threat of further instability which has facilitated advancement in excavation from established faces. The additional protection measures included application of Steel Fibre Reinforced Shotcrete (SFRS) and anchored rock bolts and replacement of buckled LG/Steel ribs with new ones. Bracing support through MS beam / plate along with additional Rock bolts/ Self-Drilling Anchor (SDA) were provided which was completely embedded with fibre shotcrete. Afterward, extensive grouting activities were carried out on potentially vulnerable zones for consolidating the poor rock mass behind the rib supports.

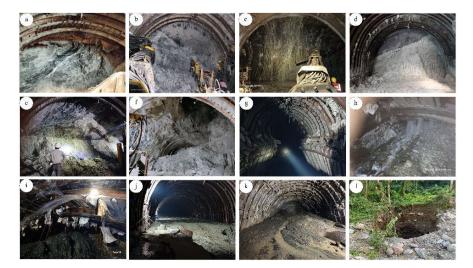
**Figure 6.** Showing Photographs of Geological hindrances faced during fresh excavation (a) Shear seams Parallel to foliation plane. (b) Shear zone at the hinge of synclinal fold. (c) vertical Shear seams at the hinge of Anticlinal fold. (d) & (e) Shear zones manifested along Fault planes. (f) Cone formation due to subparellel folaition plane (g) Squeezing in the tunnel. (h) & (i) Flowing water condition. (j) Tunnel filled with slush (k) &(l) Collapsed tunnel face & Surface Cave-in above the tunnel face.

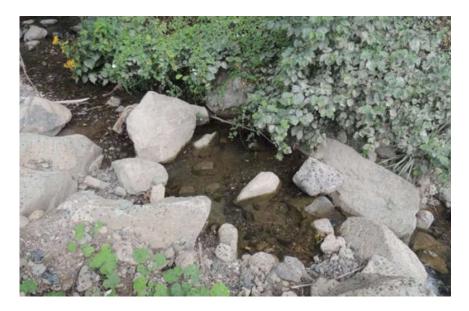
Figure 1. The Rzhanoi Creek course with boulders and fragmental material (debris).

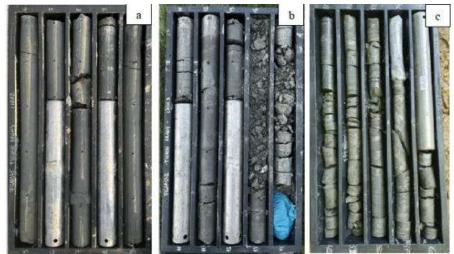
**Figure 3.** Aspects of hazadous geologic characteristics of cohesive bedrock: (a) undisturbed; (b) sheared ; (c) intensely fragmented by relaxation Pucioasa formations(*ch-aq*);

The bedrock formations, regardless of petrography / lithology or age, is found in boreholes with the specific characteristics of an overconsolidated rock, intensely fragmented by relaxation and sometimes with one or more intense shearing intervals. This situation may explain by the fact that in this specified area, all bedrocks formations were and still are subject to the following fields of efforts (Figure 2 a, b, c):

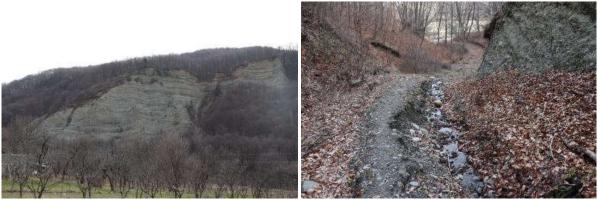
Figure 7. Aspects of the perimeter of the exploitation of sand and gravel quarry in Salatrucu

- finally, we mention here, as an important anthropic hazard, the presence of the exploitation career of sand and gravel in Salatrucu, Arges County, which is subjected to continuous regressive erosion processes under the action of rainwater, accentuated on the background of poor cementing of conglomerate formations (Figure 7).

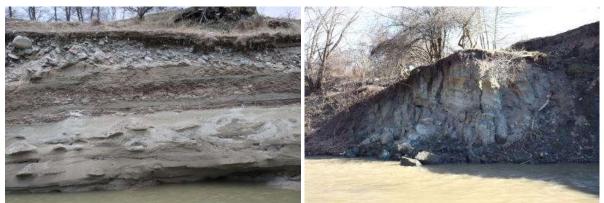
Figure 8. Undisturbed (left) and instable deposits (right) of riverbanks

- erosional processes of alluvial banks, which is active along the entire length (Figure 8);
- fewer torrential valleys affluents on the left that discharges the waters coming from the surface of the terrain and water leakages on the forehead of the alluvial plain. In one position, namely Vãleni location, it develops a limited area of terraced deposits that are shattered by an important left affluent;
- some instability phenomena at the level of connection between the minor and the major riverbed;
- finally, an important anthropic hazard on this side represents the presence of numerous and extensive bumps (positive and negative) due to chaotic exploitation of alluvial deposits or landfills, as the presence of a small concrete dam.

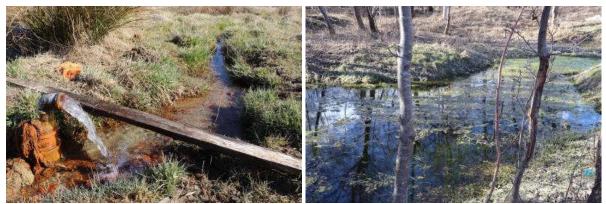
Figure 9. Artezian well and swamping areas created by vertical ascensional drainage of Cândești aquifer

generating vertical drainage phenomena when the developmental pressures are high (Figure 9).

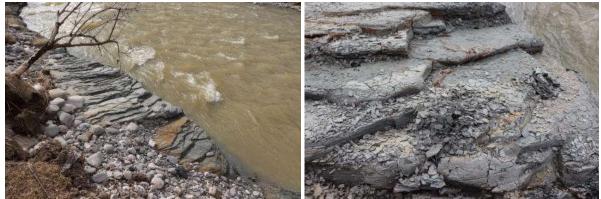
Figure 10. Cohesive bedrock in the Sothern part of the project

On this Southern part of the project, the foundation ground consists mainly of weakly consolidated or normally consolidated alluvial quaternary formations (maximum 15m thick), followed in depth by bedrock formations which include alternations of cohesive and non-cohesive complexes (Figure 10). The main risk factor is the quasi-continuous presence of soils with large swelling and contractions, both in the case of bedrock formations framed in the cohesive complex and sporadically in the fine-cohesive levels of the quaternary deposits. An extensive study of these swelling formations was based on more than 660 samples that have been tested both mineralogical and geotechnical.

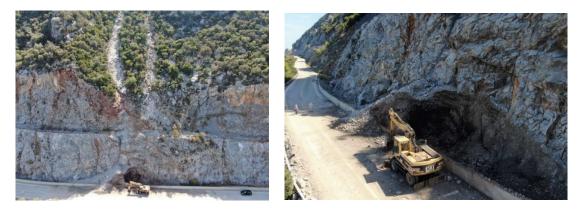
Figure 2. Debris cone and alluvial material at the base of the slope and within the road, from material accumulated through the two talweg - gullies.

The main geomorphological features observed that affect the occurrence of soil instabilities are a) the steep overhanging slopes and b) the intense erosions and gullies within the streams and torrents that flow into the road (Figure 2).

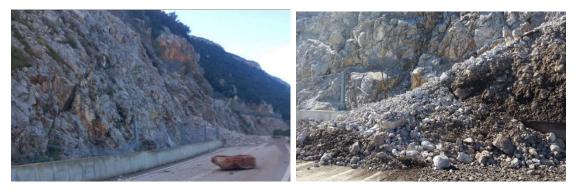
**Figure 3.** Falling of an individual boulder of 8m<sup>3</sup> (maximum bolder size of the rockfall) that bounced off the existing protection measures and ended up on the road deck within the provincial road, at about Ch. 5+525 km. Close-up view of debris flow (on the right)

Apart from bedding planes, five (5) sets of discontinuities were encountered. According to the evaluation of the Schmidt diagrams, two common failure mechanisms were identified: rock toppling and rock wedge sliding. In actual conditions, locations of rock fragment detachment, mainly large-size rock 'wedges', and the occurrence of toppling or falling/detachment of overhangs were found. A typical rock wedge failure that caused serious damages to the existing metal barrier is presented in Figure 3.

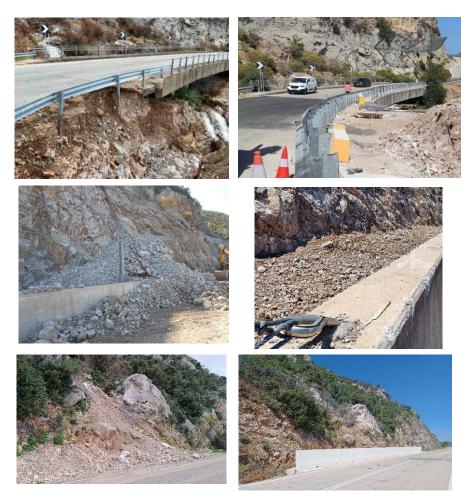
Figure 6. Characteristic views after the devastating heavy rainfall "Daniel" (left side) and restoration works (right side)

In the Figure 6, characteristic views from the restoration works are presented in contrast to the ones before mitigation measures and after the occurrence of Daniel.

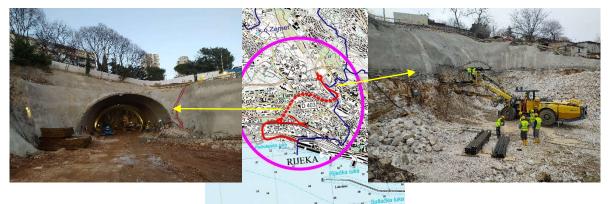
Figure 1. Tunnel "Podmurvice"

The main tunnel tube "Podmurvice" is the longest and most complex structure on the D403 route, consisting of three traffic lanes and passing under the densely built-up urban area of "Podmurvice". In plan view, the main tunnel tube has a specific curvature. The tunnel grade line is a uniform ascent of 4.5% for almost the entire length of the tunnel. The underground excavation of the main tube was carried out over a length of 1237.00 m, starting at chainage km 0+589 and ending at chainage 1+826.00 m. The elevation at the entrance portal is +78.26 m above sea level, and the exit portal is at +22.09 m above sea level, which corresponds to a height difference of 56.17 m between the two portals. The maximum overburden of the Podmurvice tunnel is approximately 50 m, and the minimum is approximately 2.00 m (IGH d.d. 2011a, IGH d.d. 2011b, Rijekaprojekt d.o.o. 2018). Within the main tunnel tube "Podmurvice", emergency pedestrian exits were constructed at an axial distance of approximately 30 m, connected to the main tunnel tube by 4 cross-passages designed exclusively for pedestrian use (Figure 1).

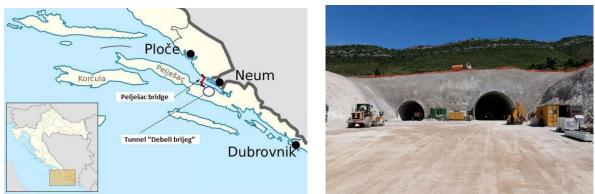
Figure 2. Tunnel "Debeli Brijeg"

The access roads to the Pelješac Bridge are part of a project to connect Southern Dalmatia, which has strengthened the connectivity of the national territory in the far south of the Republic of Croatia. As part of the construction of the access roads to the Pelješac Bridge, the two-lane "Debeli Brijeg" tunnel was built, consisting of a main tunnel tube and a service tunnel tube, which are interconnected by cross passages for pedestrian passage (9) and emergency vehicles (2). The "Debeli Brijeg" tunnel predominantly runs in a northeast-southwest direction, passing under an uninhabited area. The underground excavation of the main tube was carried out over a length of 2443.00 m. The elevation at the entrance portal (km 10+927) is +243.56 m above sea level, and at the exit portal (km 13+370) it is +240.435 m above sea level, which corresponds to a height difference of 3.12 m between the two portals. The tunnel grade line rises for the first 1100 m from the entrance portal, after which the slope decreases until the end of the tunnel structure (IGH d.d. 2016, IGH d.d. 2018). The maximum overburden of the "Debeli Brijeg" tunnel is approximately 158 m, and the minimum overburden outside the portal zones is approximately 7.5 m (Figure 2).

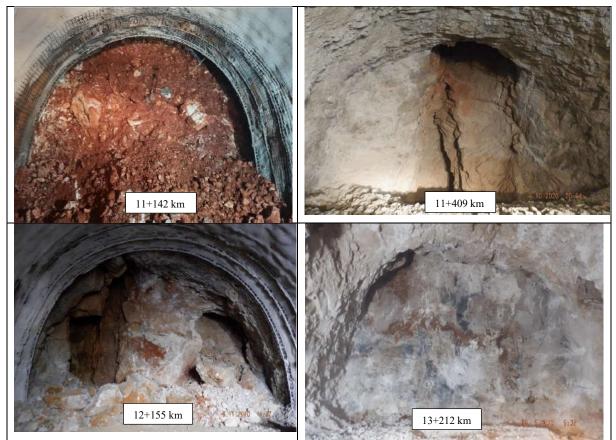
The photographs on Figure 7. show significant engineering-geological occurrences registered during the excavation of the "Debeli brijeg" tunnel. Photos are mark by the chainage location. Photo marked 11+142 km represent chainage interval from km 11+121 to 11+186 (L=65.00) where is material of the fault zone. Photos marked with 11+409 km, and 12+155 km, 12+719,50 km represent six chainage intervals from km 11+377.50 to 12+726 where are caverns without fill. Lenght of those intervals are varied fom 10 to 40 meters. Photo marked 13+212 km represent chainage interval from km 13+172 to 13+212 (L=40.00) where is fault-overthrust contact zone – rock mass mylonitization zone.

Figure 7. Tunnel Debeli brijeg (Pelješac peninsula)

Considering that all the mentioned materials belong to soil and unfilled caverns for which the RMR classification was not applicable, the excavation was automatically classified and executed in the V category according to the GTS (general technical specifications for tunnel works). All the mentioned engineering-geological occurrences, in the context of the prognosis of poorer rock mass quality, were not predicted, which proved to be one of the significant disadvantages in the research phase

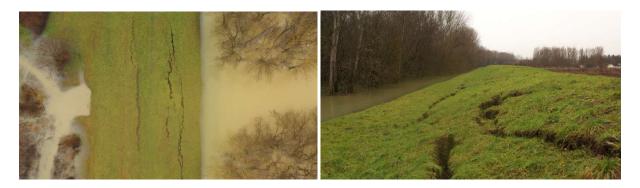
Figure 1. Deformed levees as a consequence of earthquake - induced liquefaction in Sisak - Moslavina County

As one of the consequences of the strong Petrinja earthquake in 2020, liquefaction occurred in large parts of Sisak–Moslavina County, whose geology is generally characterized by saturated, poorly graded sands and silty sands (Pollak et al., 2021). In the Rapid Damage Assessment Report (Republic of Croatia, 2021), it was estimated that liquefaction occurred on almost 1600 ha of the county area at varying depths from 3 to 15 m. All liquefaction zones are located in the alluvial deposits of the Kupa, Sava, Glina and Maja rivers at a maximum distance of about 1 km from the riverbanks. About 7% of the area affected by liquefaction is located under the levees. This was detected by numerous cracks in the ground surface and erupted sand, as well as numerous cracks and deformations of the levees (Figure 1).

The levee deformations shown correspond well with the levee damage patterns D-2 and D-3 of Oka et al. (2012) (Figure 2), which were detected after the magnitude 9.0 Tohoku earthquake in 2011 in Japan, where damage to the levees was recorded at 2,115 locations. These patterns include longitudinal cracking and lateral expansion of the levee slope near the toe, as well as settlement of the levee crest. The authors state that the associated damage is due to liquefaction of the foundation soil, liquefaction of the soil in the levees as the water-saturated area was above ground level, and the long duration of this huge earthquake, or a combination of the above factors.

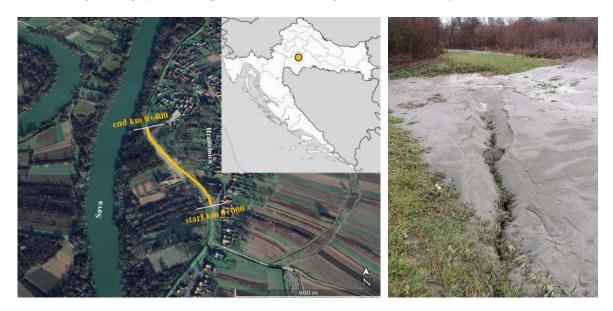
Figure 6. The layout of the damaged section of Hrastelnica levee with observed sand ejecta

As a result of the 2020 Petrinja earthquake, a levee on the left bank of the Sava River in Hrastelnica, Sisak-Moslavina County, showed significant deformations and cracks on the crest, slopes and surrounding soil. The length of the damaged section is 400 m, from km 106+200 to km 106+600 (Figure 6). The damage is largely due to liquefaction, with a large amount of sand ejecta observed.

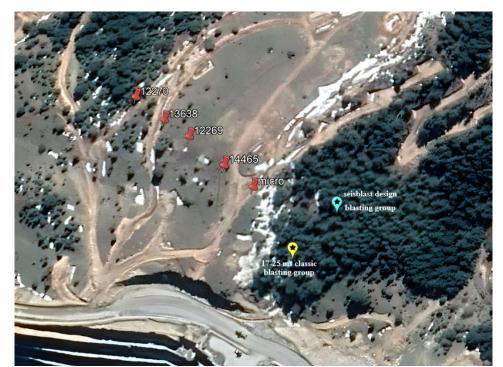
Figure 1. Group blasting locations and seismograph locations (Seismographs: micro,14465,12269,13638,12270)

Group blasting locations and seismograph locations are given in Figure 1.

Seismic waves from the pilot blasting were recorded with 4 seismographs and seismic waves from the group blasting were recorded with 5 seismographs. Thus, it was possible to analyze and analyze the seismic waves generated by the blasts with electronic capsule and to compare them with the results of previous blasts in the same area with conventional delays (17-25 ms) and seismic recordings made by us using Seisblast Promax software. For group blasts, the nearest seismograph (micro) was placed 60 m away from the blasting location and the farthest seismograph (12270) was placed 182 m away.

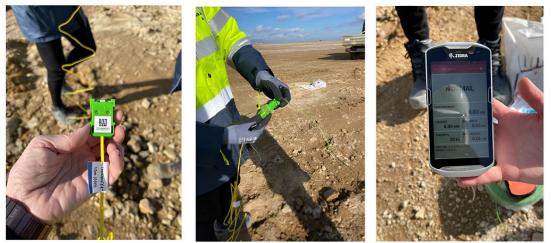
Figure 3. An image from the field application of electronic capsules

Electronic capsule delays were determined by us, uploaded to the logger and defined to the capsules in the field (Figure 3).

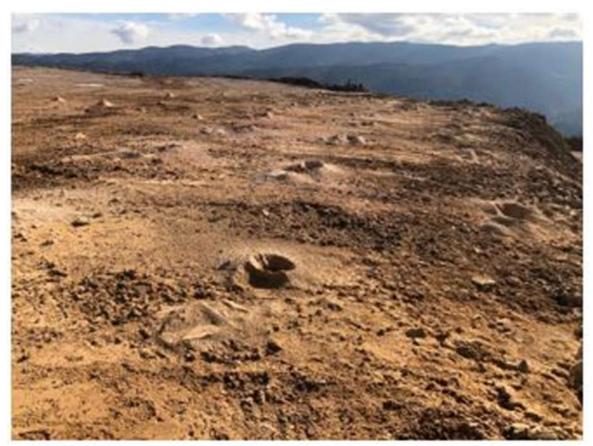
Figure 14. Group blast holes

Group blast holes are shown in figure 4.

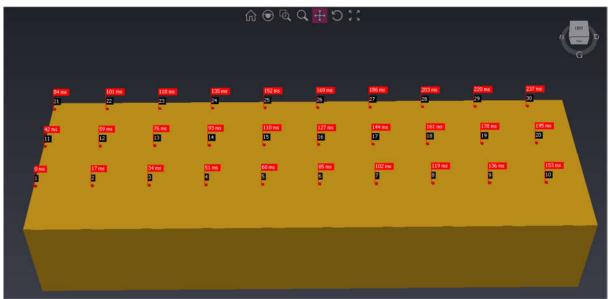
Figure 5. Delays applied to the holes for conventional blasting system

Figure 5 shows the delays applied to the holes for conventional blasting and Figure 6 shows the delays applied to the holes using Seisblast Promax software, respectively.

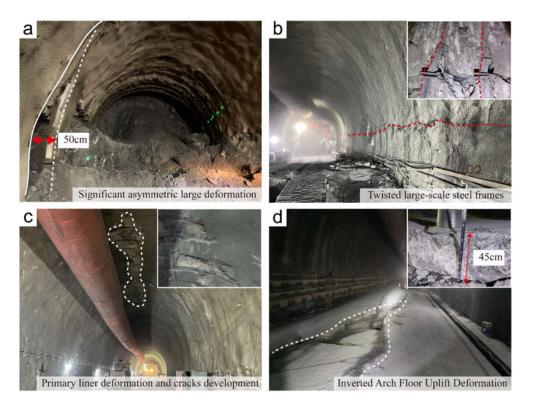
Figure 1. Large deformation and typical failure characteristics of supporting structure of tunnel project.

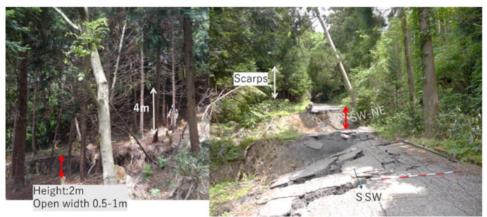
Figure 7. Image at Loc. I, showing the southward lowering of a step on the west side of *Hattaro* Pass, which occurred approximately 5 m in front of a small cliff topography (4 m high).

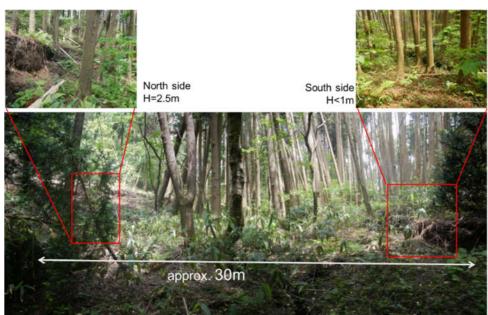
**Figure 9.** Image at Loc. III. Graben structure is observed. The north side of the depression is tilted south, and the south side is tilted north.

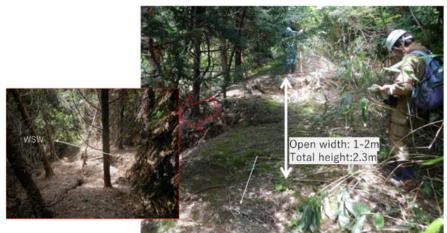
Figure 10. Image at Loc. IV. Step-fault like deformation of north side of depression and scarps extending to WNW direction

- Loc.IV Multiple terraces are distributed on the steps in the south-falling terrain. Multiple terraces are distributed on the step, and openings were observed at 0.2–1.0 m on each terrace (Figure 10).
- Loc.V Deformed topography (vertical offset of 1.2 m and right lateral offset of 1.6 m) was observed inside the mobile unit (Figure 11).
- Loc.VI The prefectural road overlooking the Suzuya River was completely collapsed (Figure 12).
- Loc.VII A strange slope extrusion phenomenon was observed in the upper part of the prefectural road (Figure 13).

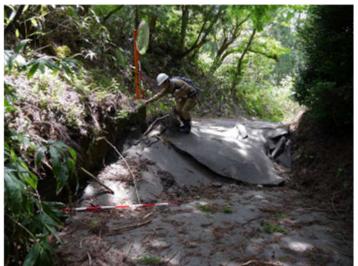
Figure 11. Image at Loc. V. Internal deformation of mobile unit, with 1.2 m longitudinal displacement and 1.6 m horizontal displacement on the right side.

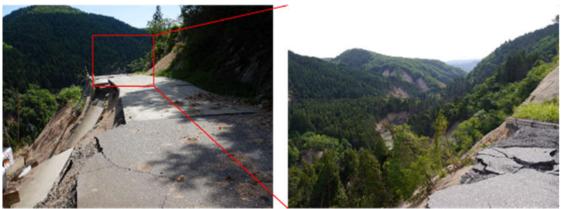
Figure 12. Image at Loc.VI. Collapse of a prefectural road.

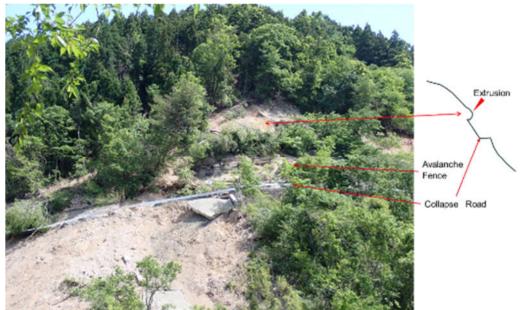
Figure 13. Image and Simplified sketch (cross-section) at Loc. VII. Extruded area at the southern end of the landslide

Based on a field survey, a series of slip cliffs and graben structures appeared at the northern end of the landslide. These structures have good continuity in the east-west direction, and both are at the edge of the moving landslide body because of the low deformation on the south side. The maximum width of the graben structure was 30 m, and a maximum drop of 2.5 m was observed on the north side. This drop is larger than the 1 m drop on the south side of the graben structure and is the basis for the main slide cliff. Various deformations are observed in the internal structure of the landslide. On the southern side facing Suzuya-River no terraced topography corresponding to a slip cliff was observed. Instead, as shown in Figure 13, extrusion and collapse were observed on many slopes.

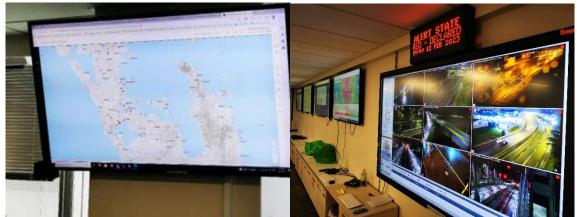
Figure 4. NZ Landslide Database feed on an Emergency Control Centre display during emergency response.

A live data feed from the NZ Landslides Database provided through an API enabled a map to be shown in the Auckland Emergency Management Emergency Control Centre (Fig 4). This displayed public reports of landslides in real time. Members of the public submitted 118 landslides through the public reporting tool during the 27 January to 14 February period in the Auckland region.

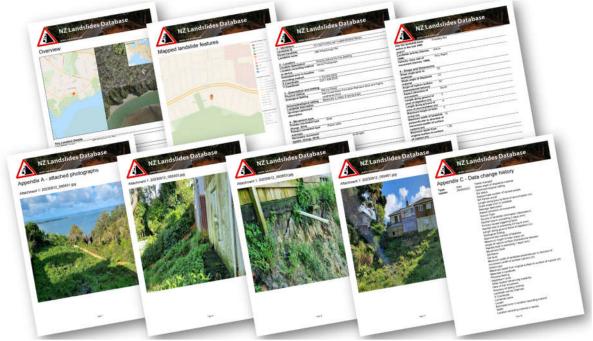
Figure 5. Example NZ Landslide Database automatically generated report.

This feed greatly added to situational awareness in the control centre, enabling prioritisation of emergency response and allowing the Controller to understand which areas were worst affected. Once the emergency response was completed, more comprehensive data collection commenced. A combination of satellite imagery, aerial photography, LiDAR, and detailed on-site assessments are being used to validate public reports, to add technical detail to these reports, and to add landslides where no report was made. Detailed assessments were made of over 250 landslide affected homes. Each of these was mapped directly into the database, and the reports automatically generated from the database to ensure consistency and improve efficiency (Fig 5).

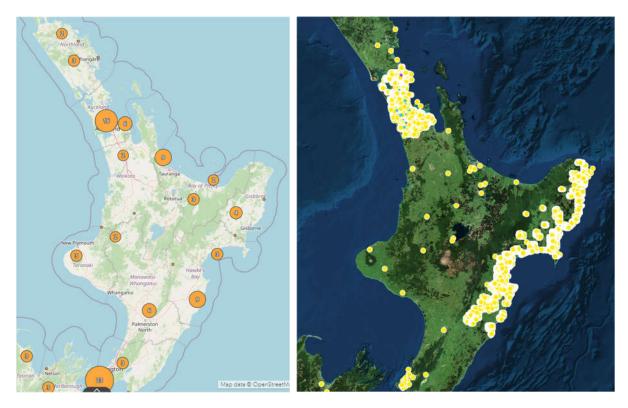
Figure 6. Comparison of the NASA Landslide Viewer (left) showing 56 landslides on the North Island of New Zealand and the NZ Landslide Database showing 150,000 landslides in the same area.

There are few international landslide databases available. A prime example is the NASA Cooperative Open Online Landslide Repository (e.g. Juang et al, 2019) (Fig 6).

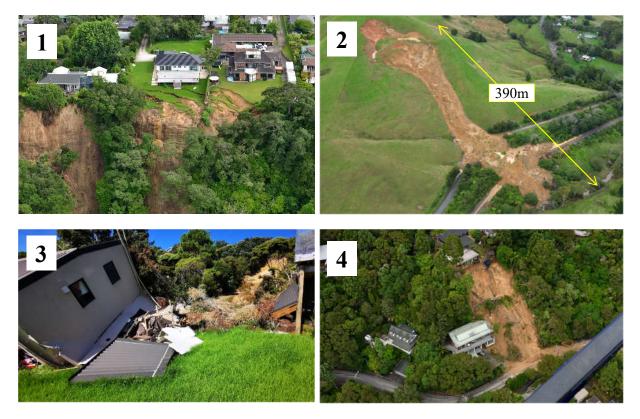
**Figure 6.** Examples of Auckland landslides triggered in 2023 which affected homes and infrastructure. 1) Typical cliff-top failure in residual deposits of the East Coast Bays Formation. 2) Rotational failure of residually weathered clay transitioning to a flow inundating a road and main railway line in north Auckland. 3) A twostorey home pushed about 20 m off its foundations in Muriwai. 4) Shallow translational slide common on steep slopes in west Auckland.

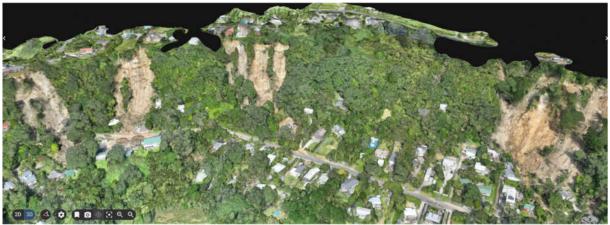
Figure 7. Example 3D model from drone from Muriwai, collected and published three days after the landslides.

Pix4D Mapper cloud was used for 2D orthomosaic stitching and 3D model reconstruction from drone data, enabling very rapid model production and sharing. These datasets were published online (https://landslides.nz/data/) to allow free access for infrastructure providers, emergency services and others, and proved very useful in assessing geomorphology, landslide run-out and the Fahrböschung (F) angle.

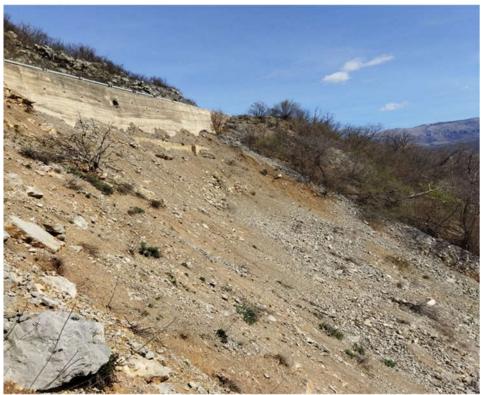
Figure 1. The initial state of the landslide, March 2023

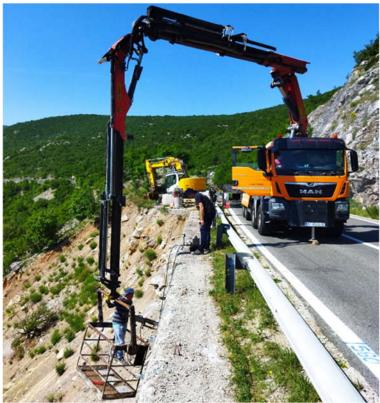
Each anchor was tensioned to a force of 130.0 kN, 7 days after injection. The anchors were tensioned using a hydraulic press while monitoring the applied force and displacement in the anchor. Three anchors were tested with a force of 185.0 kN. The anchors are grouted with cement suspension, with a water-cement ratio of 0.42 and 1% swelling additive based on the mass of cement.

Figure 4. Installing of rock anchors

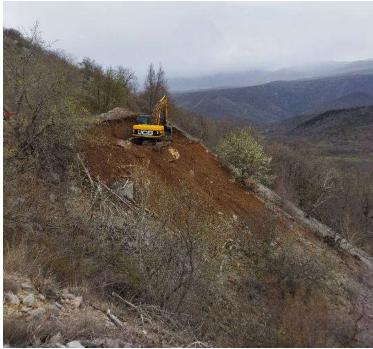
To facilitate work on the sliding body, an access road was constructed from the state road to the lowest elevation of the structure. This road served for the transportation of machinery and delivery of materials. As construction progressed to the level of the state road, adjustments to the access road were necessary. It was always extended to the bottom level of each floor's foundation to provide maneuvering space for machinery.

Figure 5. The beginning of the construction of the access road

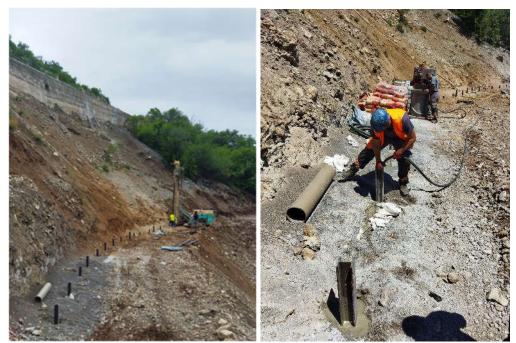
The foundation of the lowest floor of the structure, made of reinforced soil, was constructed in combination with micropiles with a diameter of 180 mm and a length of 6.0 m. The micropiles were installed at an axial distance of 2.0 m, covering a total length of 58.0 m, resulting in the installation of 30 micropiles.

Figure 6. Installation of micropiles

After drilling a borehole with a diameter of 180 mm, HE 120 A steel profiles, 6 m long, are inserted into the borehole. The entire borehole is then injected with a cement suspension with a water-cement ratio of 0.42 and 1% swelling additive per cement mass. Seven days after the completion of grouting, a pile integrity test is conducted, which is a prerequisite for proceeding with the construction of the head beam.

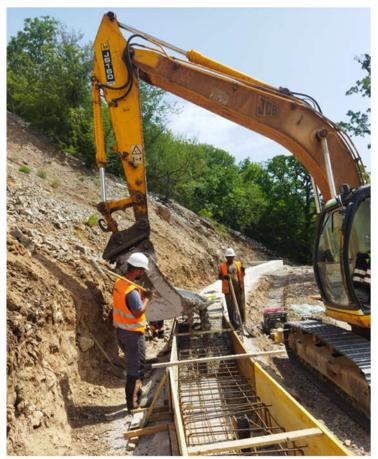
The head beam is 60 m long with a cross-sectional dimension of  $80 \times 40$  cm. For its construction, 19.50 m<sup>3</sup> of concrete of compressive strength class C30/37 and 1500 kg of reinforcement were utilized. The main challenge was the delivery of fresh concrete to the beam's position, accomplished by using an excavator bucket. Concrete was transported to the beginning of the access road by a concrete mixer, and then loaded into the excavator's bucket. The installation with concrete pumps was not feasible due to the considerable distance from the state road to the bottom of the beam, which exceeds 40 m.

Figure 7. Construction of head beam

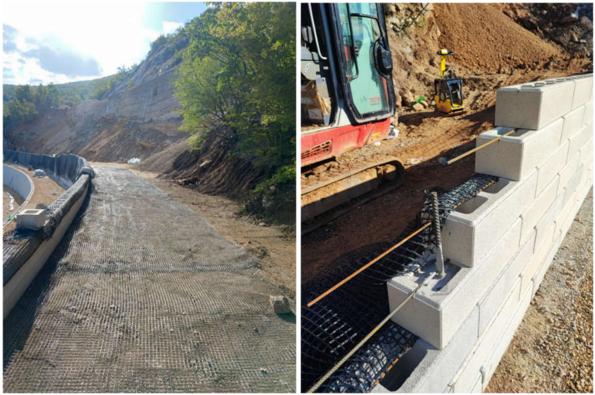
Longitudinal reinforcement, consisting of bars with a diameter of 6 mm, is positioned in each row of blocks. In every other row, a geogrid, serving as a tensile element, is attached around the longitudinal reinforcement. The geogrid is placed 3 m wide behind the wall, with an overlap of 0.50 m over the longitudinal reinforcement. The longitudinal reinforcement is inserted into slots within the blocks.

At an axial distance of 2.40 m, or in every fourth block, a reinforcing bar with a diameter of 20 mm is inserted to vertically stiffen the face of the wall. The rod is anchored into the foundation of each floor by 20 cm, and the rods are continued by overlapping for a length of 50 cm. After the vertical bars are installed, the cavity inside the block is injected with a cement mixture for rock anchor injection. Figure 8 illustrates the components of the reinforced soil construction: wall face, longitudinal reinforcement, geogrid, vertical stiffener, and embankment.

Figure 8. Reinforced earth elements

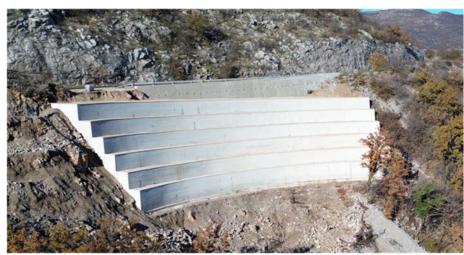
Stone material with a granulation of 0-75 mm was used as the filling material. The material was compacted using vibrating plates, ensuring a compressibility modulus (Ms) greater than 40 MPa. In total, 4,300 m<sup>3</sup> of stone material was installed. Figure illustrates the completed construction after finishing the works.

Figure 9. Completed construction, October 2023

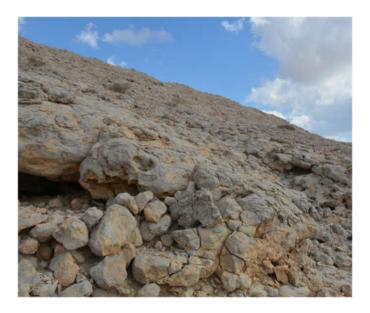
Figure 2. A typical rock blocks from sampling sites.

Field trips were conducted to obtain sixty representative carbonate rock blocks samples (approximately 30x30x30 cm size) from the Simsima, Dammam and Asmari Formations from the study areas (Fig. 1, Fig. 2, and Fig. 3a). After a quality inspection of the blocks to eliminate any with visible discontinuities, fractures, filling material, etc., a subset of forty-three blocks, comprising twelve, sixteen and fifteen

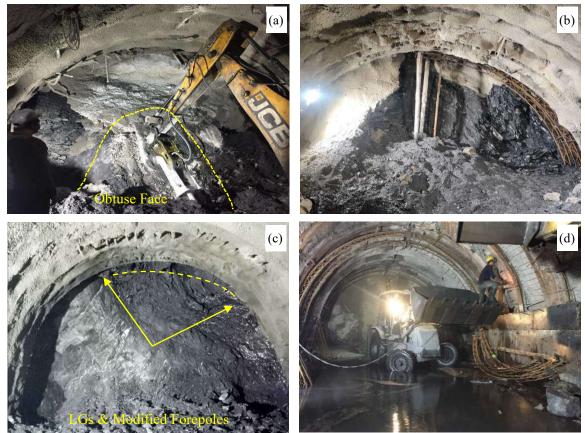
Figure 5. (a-b) Obtuse face method and multi-segmental-cum mechanical excavation method adopted for tackling weak rockmass/low-cohesive coal bands; (c) Unlike conventional 135° arc, forepoles with 32Φ bars/SDAs alternately with modified positioning as per disposition of weak strata; (d) Fusion of LGs with steel ribs as supplementary rock support mainly in distress zones.

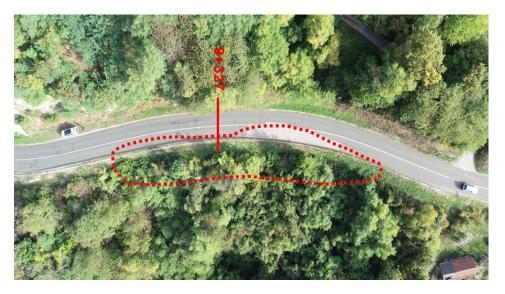
planned remediation is in the area of road subsidence, specifically around a landslide on the downhill slope at km 9+327 of the State Road DC206, as shown in Figure 1.

Figure 16. Area of instability and planned remediation, State Road DC206

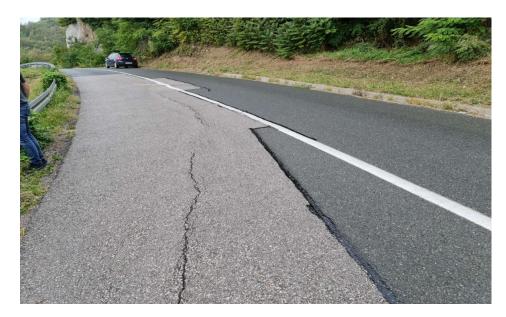
An engineering visual inspection revealed that there was no rainwater drainage, instead, water is partially drained via curbs along the uphill edge of the road, directing water along the longitudinal gradient. Most of the rainwater flows down the slope, driven by the transverse gradient of the road. Surface drainage is further hampered by accumulated material in the narrow area next to the curbs. The accumulation of material on the uphill side is a result of water erosion and the washing away of cover material. Figure 2 shows a crack about 15 meters long, observed on the western part of the intervention area, located 1 meter from the edge of the road. The figure also shows a very steep slope covered with dense vegetation on the uphill side.

Figure 17. Western part of the road with developed crack about 15 meters long

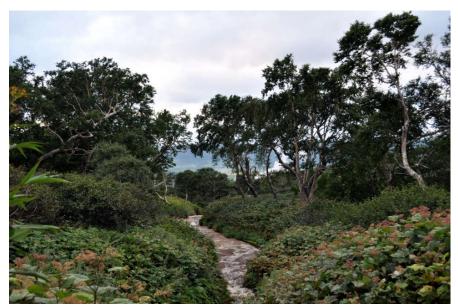
Figure 3. General view of the ecological-geological system of the tuff massif of the Pauzhetsky geothermal region

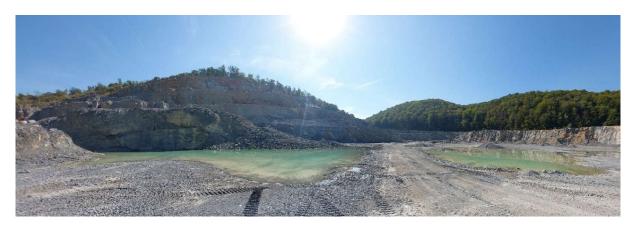
Figure 1. Panoramic photo of the research floor, 208 m.a.s.l.

Problems with water management in the specific case (Čelina mining field) studied in this paper began in 2021. A new feature of water accumulation in the form of water pools appeared on the quarry floor (208 m.a.s.l.), where the water had a tendency to flow towards the northern part of the excavation floor (Figure 1.). Given that the inflow of water did not decrease over time, it was not possible to continue the management of the quarry as a natural resource of rock material. Such an unfavourable situation could have been prevented by carrying out detailed investigations before the quarry started working. Such extensive studies would assess the local impact on groundwater flow systems. However, considering that research was not carried out before, detailed geophysical and geological investigations were carried out at the end of 2023 to detect the source and extent of groundwater springing. In addition to geological prospecting, three different methods of geophysical investigation were applied: electrical resistivity tomography (ERT), multichannel analysis of surface waves (MASW) and ground penetrating radar (GPR). Input data for research planning was obtained from the results of exploratory drilling with a depth of 50 meters that was performed near the place where the water appeared. Artesian water came to the surface from the well, confirming groundwater's presence.

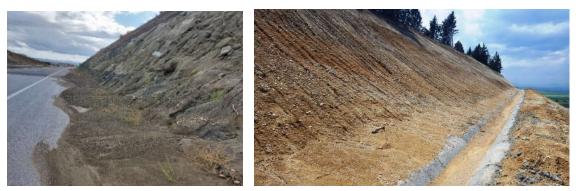
Figure 1. Slope exposed to intensive erosion on the Highway Miladinovci - Shtip, N. Macedonia.

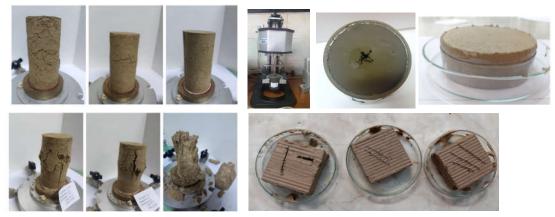
Figure 4. Soil samples from laboratory tests.

The strength-deformation characteristics of the material were obtained through tests of Uniaxial Compressive Strength, Direct shear, Vane, and Oedometer tests. The water permeability has been determined for a pressure of 0.5 bar for saturated samples, Figure 4.

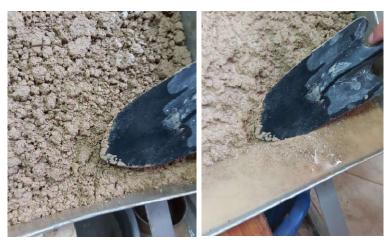
Figure 9. Eroded soil in 180 minutes of rainfall for polymer-improved slope (left side) and natural slope (right side).

A series of tests on untreated and biopolymer-treated slopes with grown vegetation were also tested on 120 minutes of rainfall with an intensity of 12 l/h. During the rainfall, no erosion was observed, hence, the biopolymer-treated slope has a higher stability and resistance to erosive forces (Nikolovska et al. 2023). For precipitation duration of 3 h on an area of 1.0 m<sup>2</sup>, a material with a weight of 1900 gr is eroded, which represents a loss of material of 9.5%, Figure 9.

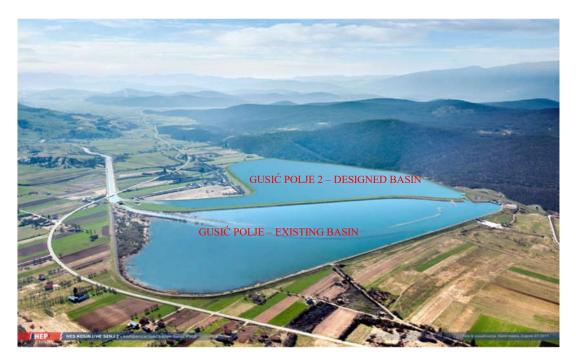
Figure 1. The broader project area showing the existing Gusić polje basin and the designed Gusić polje 2 basin

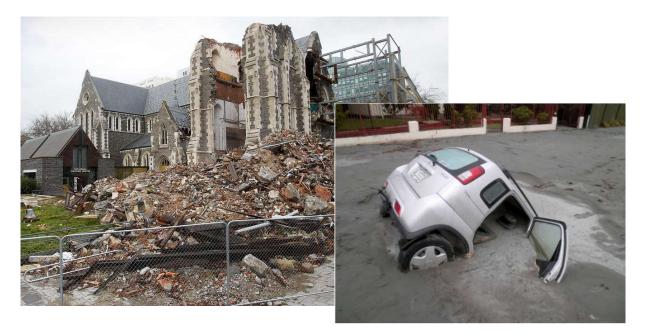
Figure 3. Photos from the 2010-11 Canterbury Earthquakes including this car (right) toppled into one of many large holes created by liquefaction (source: Stuff.co.nz and the Encyclopaedia of NZ)

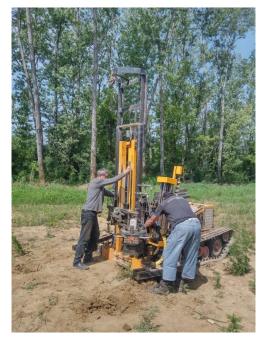
Figure 1. Cone Penetration Testing in the area of Petrinja

Since the liquefaction potential assessment required relatively fast and effective methods to be implemented, and considering the large area and many locations to be covered, an investigation campaign included a cone penetration test (CPT) method, Figure 1. Based on the analysed and interpreted results, a direct insight into the state of the soil from the aspect of dynamic instabilities (likelihood of liquefaction) was obtained. In view of the very large and statistically relevant amount of data collected, a map of the specific region of the county was developed by interpolating the results obtained. Thus, this map can be directly compared with the previous efforts to assess liquefaction on large-scale, which were based on limited indicators and relying mostly on existing geological maps and not on measured subsurface data.

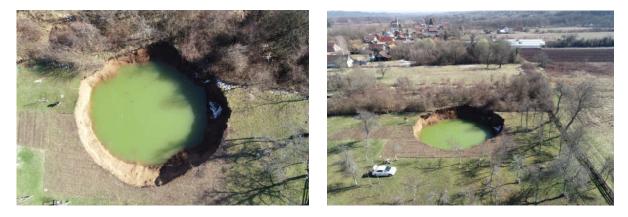
Figure 2. Largest sinkhole (UVM-001) occurred as a consequence of the Petrinja 2020 earthquake

This paper focuses on the rapid assessment activities carried out in sinkhole occurrence area, which led to sinkhole categorization and served as a starting point for the development of the remediation design and the implementation of the remediation measures. While the general assessment methodology is explained, the planning and remediation design and work is demonstrated using the example of the largest collapse sinkhole (UVM-001) with a diameter of 25 m and a depth of 13 m (Figure 2).

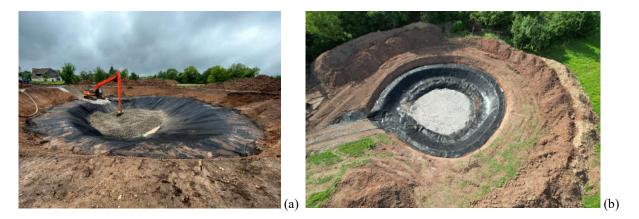
Figure 10. Backfilling works using long reach excavator (a) and aerial view of material type 2 placed and compacted (b)

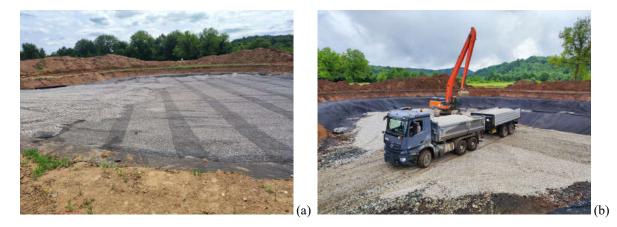
Figure 11. Installed biaxial geogrids (a) and heavy machinery inside the sinkhole (b)

During the backfilling work, several heavy rainfall events occurred, which prolonged and made the remediation work more difficult. However, the combination of the compaction of the backfill material and the installation of geogrids (Figure 11a) provided a solid foundation for the work of the heavy machinery (Figure 11b). This can be also considered as a large-scale load test which verified design solutions since no problems occurred regarding excessive deformation or settlements of backfill material Finally, a clay cap was installed (Figure 12a).
