YEG-Article-15/2026

Why engineering geological characterization of rock masses is vital for hazard assessment? - A rock slide case in Mudurnu, Türkiye

Arzu Arslan Kelam

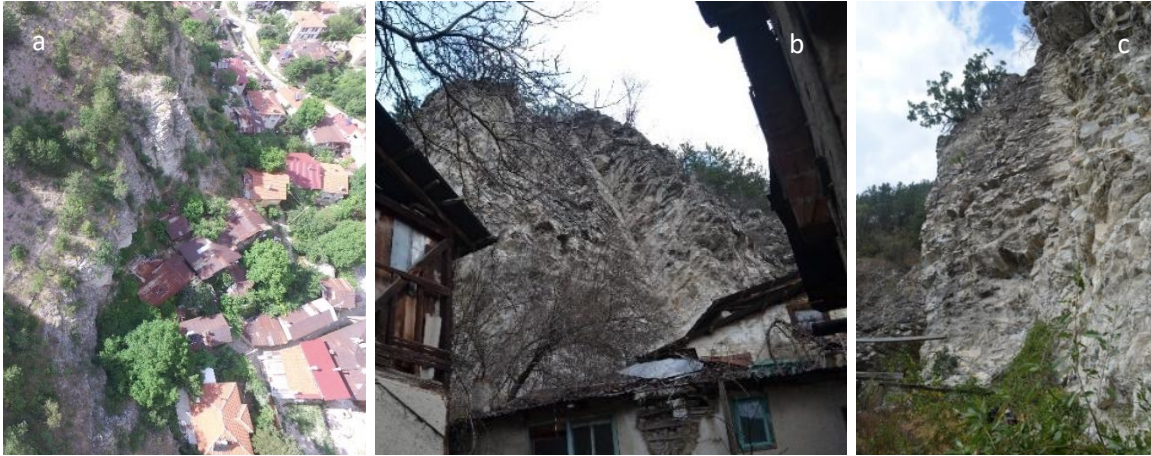
Figure 2 Images of the rock slope and the houses under threat.

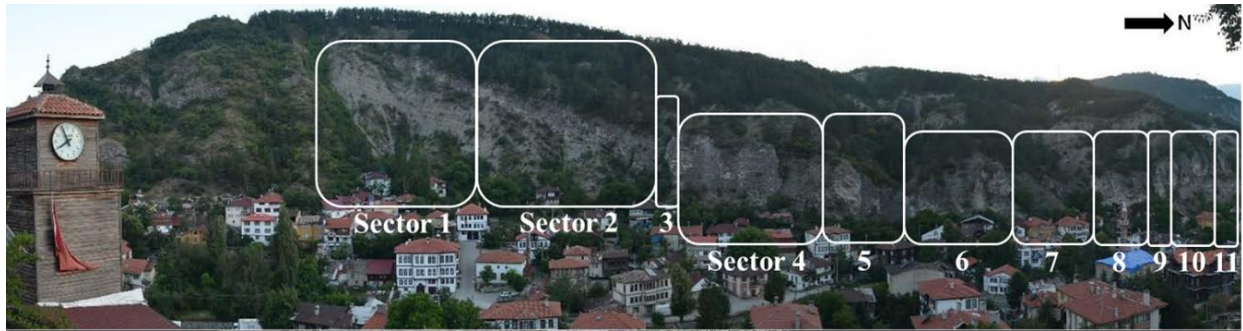
Figure 3 Defined geomechanical sectors.

engineering geological evaluation resulted in the identification of 11 sectors that possessed similar geomechanical properties (Arslan Kelam 2022) (Figure 3).
