XIV IAEG Congress 2023 Field Trip

Field Trip #1: Hydraulic engineering masterpiece, Earthquake damage and Geohazard

Topic: (1) Two engineering masterpieces will be introduced at first (Dujiangyan Irrigation System and Zipingpu Reservoir Dam), (2) Some post-earthquake geohazards consequent on the Wenchuan earthquake in 2008 will be introduced. (3) Overview large-scale debris flow mitigation structures

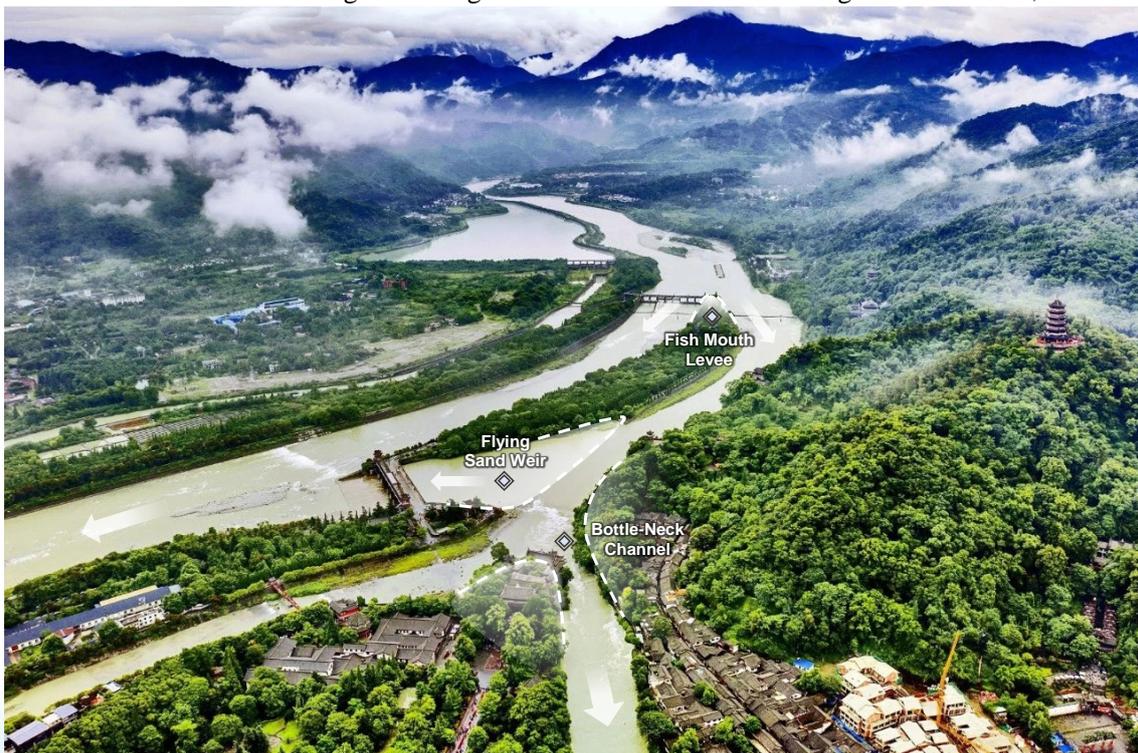
Fig. 2 The dujiangyan irrigation system

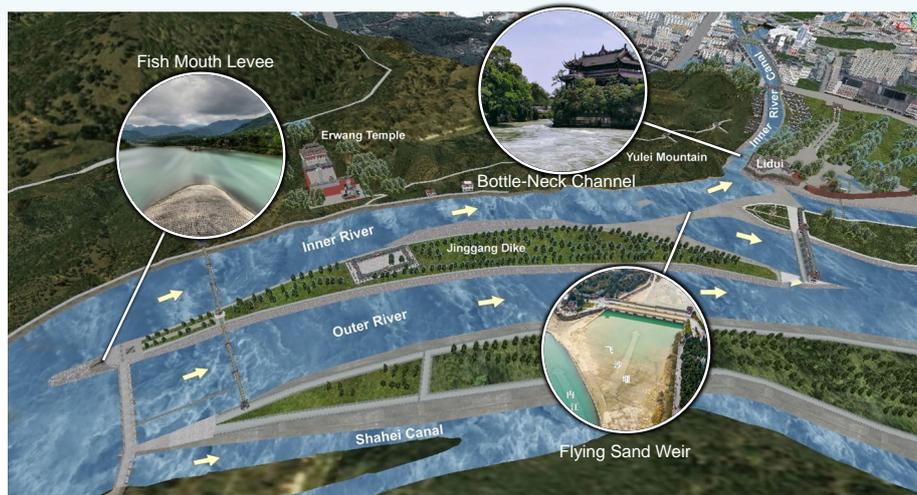
Fig. 4 The position of the Fish Mouse Levee (Yuzui), the Flying Sand Weir (Feishayan), and the Bottle-Neck Channel (Baopingkou) consist the three main constructions of the Dujiangyan irrigation system.

The irrigation system consists of three main constructions that work in harmony with one another to ensure against flooding and keep the fields well supplied with water:

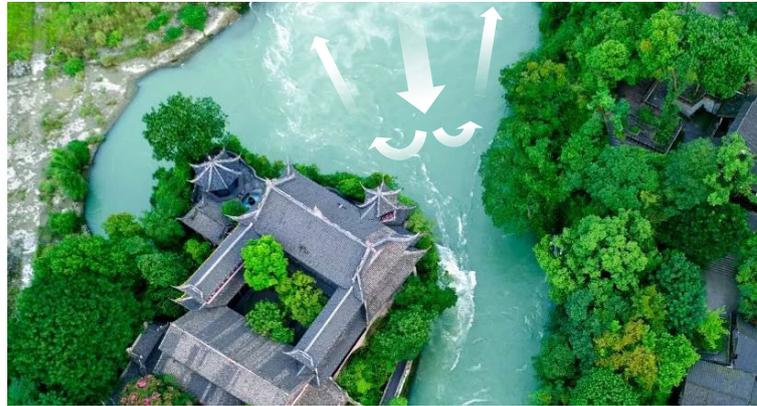
Fig. 7 The Bottle-Neck Channel (Baopingkou) controls the discharge to the Chengdu Plain, and also creates whirlpool flow to bring back sand to Feishayan and Fengqiwo upstream.

The Baopingkou or Bottle-Neck Channel (Chinese:宝瓶口), which was gouged through the mountain, is the last component of the system. The channel is responsible for distributing the water to the farmlands in the Chengdu Plain, whilst the narrow entrance The narrow entrance of the channel, from which it gets its name, acts as a check gate, creating a swirling current that discharges any excess water over the Flying Sand Fence, thus preventing flooding.

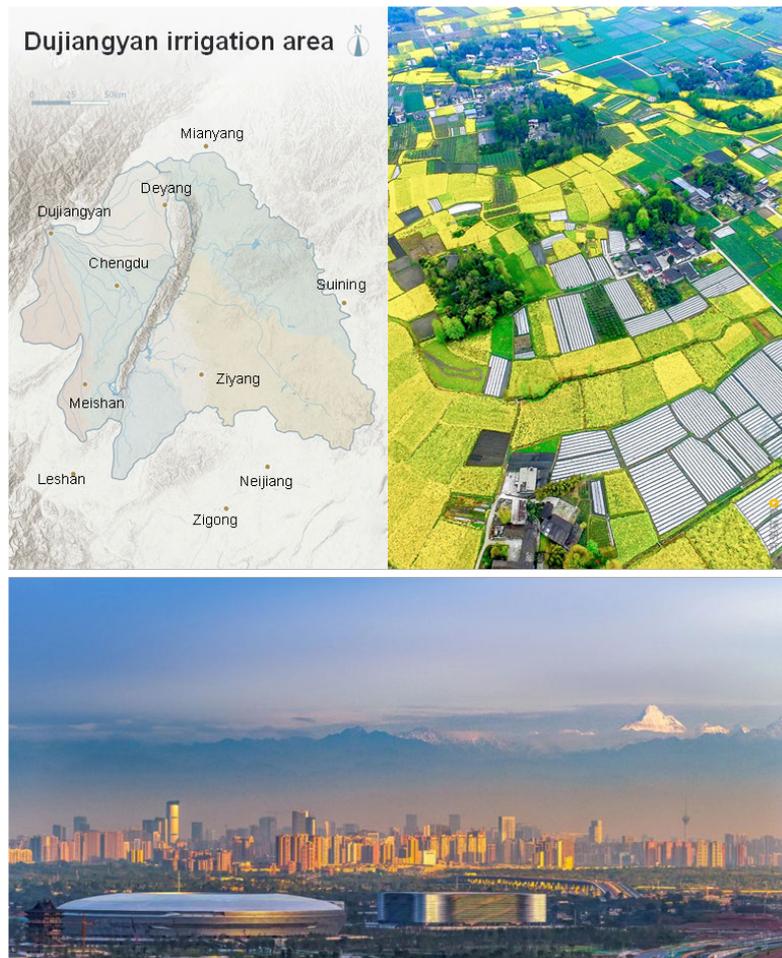
Fig. 8 The Dujiangyan irrigation system is still in use today to irrigate over 5,300 km² in the Chengdu plain region and has produced comprehensive benefits in flood control, irrigation, water transport and general water consumption.

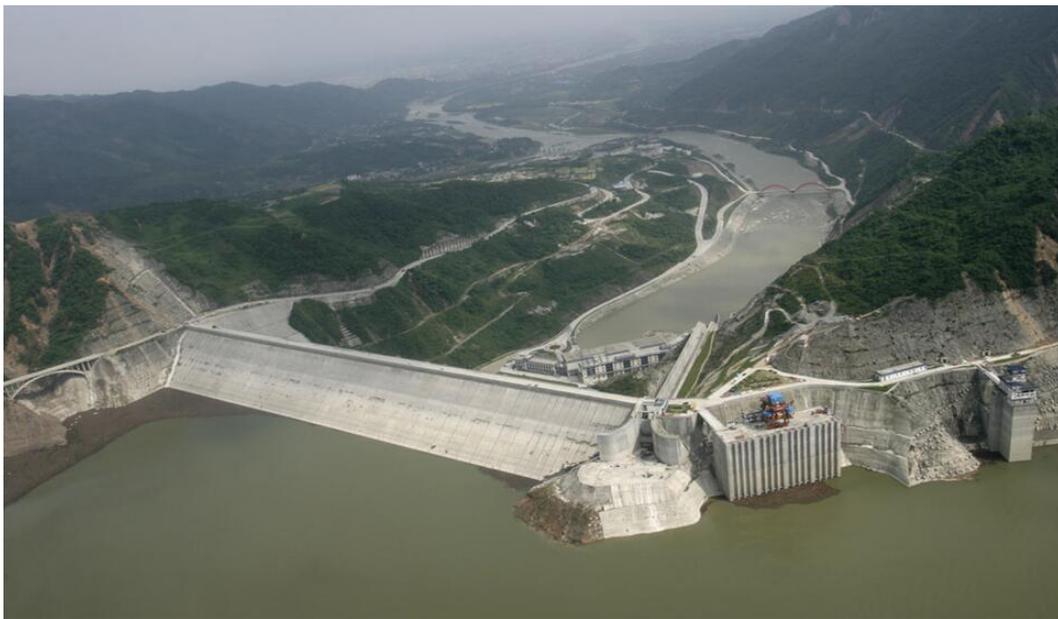
Fig.9 Panorama of Zipingpu Water Conservancy Project.

The Zipingpu Water Conservancy Project is located on the MinJiang River, 9 and 60 km respectively upstream from the Dujianyan City and Chengdu City-the capital city of Sichuan Province. The Minjiang River has a catchment area of 22662 km² above the dam, with a mean annual flow of 469 m³ /s and an annual runoff of 14.8×10⁹m³. The main functions of the project are irrigation and water supply, with comprehensive benefits in power generation, flood control, environment protection and tourism. The check and design flood levels, the normal and minimum pool levels are 883.10 and 871.20, 877.00 and 817.00 m, respectively. The total capacity of the reservoir is 1.112×10⁹m³.

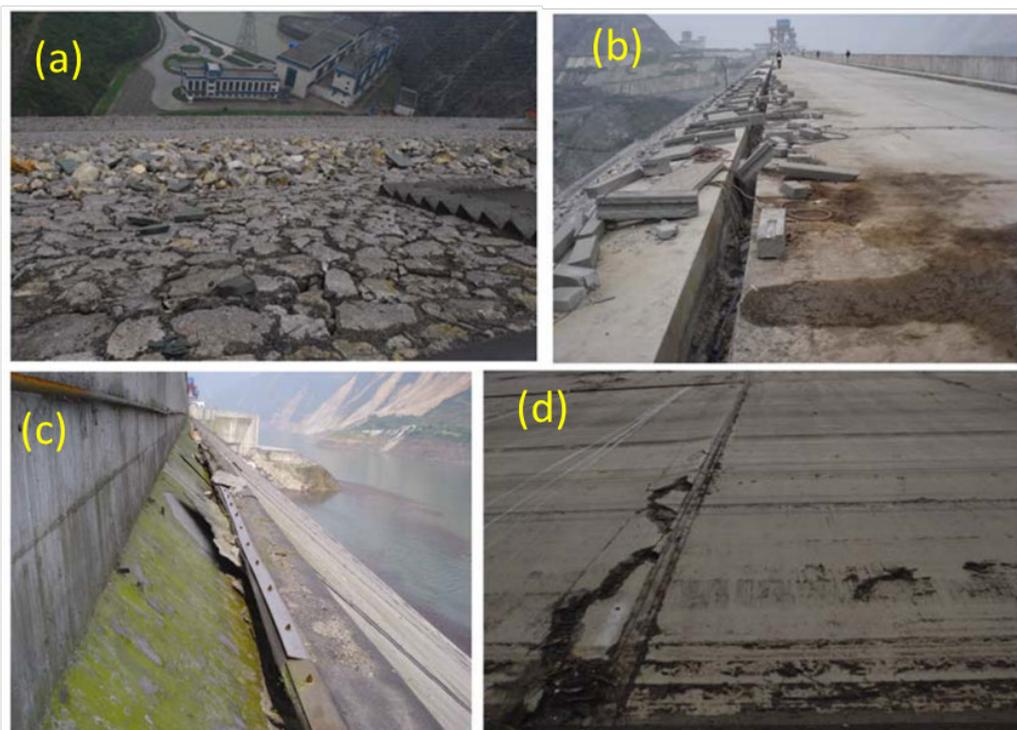
Fig. 11 Earthquake damages to the project structures. (a) Loosen rock fills on the downstream side of the dam; (b) Open and dislocation of the downstream border of the dam crest; (c) Damages of the horizontal joints at the dam crest resulting from subsidence of the wave wall; (d) Squeezing damages between the No. 23 and No. 24 slabs.

The damages of structures include cracking of the curb stones on the downstream side of the dam crest, tensile cracking and squeezing damage of the “L-shaped” up-stream wave wall, occurring respectively on its both sides and in its middle part.

The horizontal joints between the slab top and the wave wall were dislocated, resulting from the seismic subsidence. The rock fills were loosen and dislocated by the earthquake at the location of about one fifth of the dam height in the middle part of the dam. Some slabs were separated from the cushion layer and some construction joints were dislocated and some vertical joints were damaged by squeezing.

The No.5 and No.6 slabs on the left abutment were heaved up by squeezing and damaged severely, with a maximum dislocation of 350 mm. The joint between the No. 23 and No. 24 slabs was damaged by squeezing, extending from the dam crest to the elevation 791.00 m, 26.0 m below the dead storage level. The No.23 slab was damaged with a transverse width of 0.5-1.7 m, and a depth of 320 mm and a separation void of 50 mm, according to borehole inspection at the elevation of 843.00 m. The

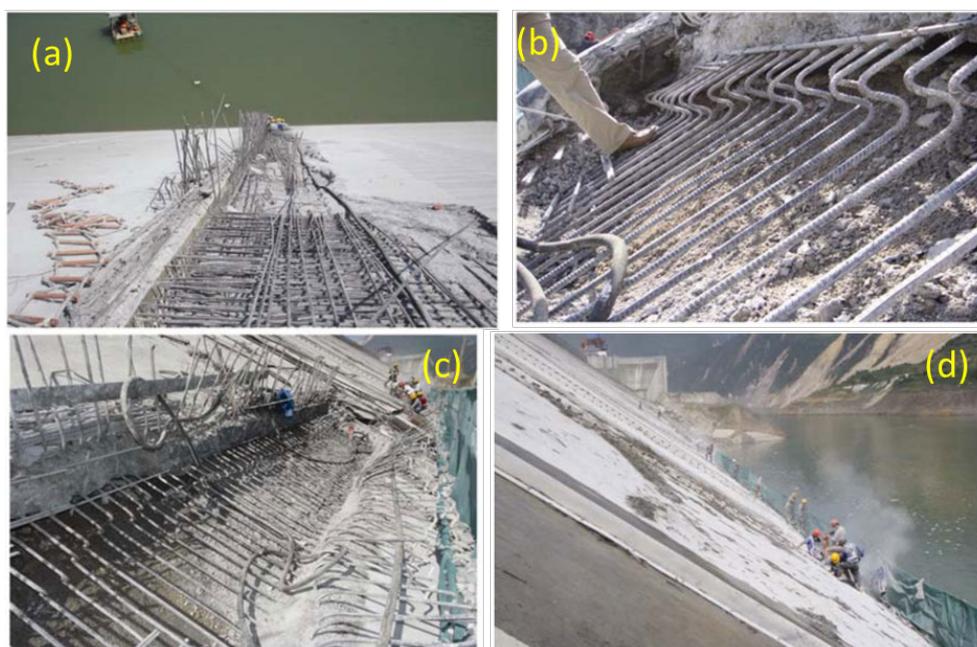
Fig. 12 Dislocation of the horizontal construction joints of the slabs. (a) Excavation of the damaged longitudinal joint of the No. 23 slab (after removal of the broken concrete). (b) The exposed horizontal joints at El. 845 m after local removal of concrete. (c) Repairing the dislocated horizontal joints of the No.8 slab (the stress bar bended in “S” shape). (d) Repairing construction of the damaged slabs.

The construction joints of the second- and third-phase slabs were found dislocated obviously, with a dislocation of 15-170 mm for the slabs Nos. 5-12, 120-150 mm for the slabs Nos. 14-23, and 20-90 mm for the slabs Nos. 30-42, covering a total length of 340 m. After removal of the damaged concrete on the surface, it was found that the dislocation of the No. 8 slab caused “S” shaped bending of the stress steel bars in the middle part of the No. 8 slab, cracking and separation of the concrete below the stress steel bars of the third-phase slabs and breaking of the contact concrete. The horizontal dislocation of the No.10 slab reached 230 mm, resulting in shearing off of the copper seals between the slabs and exposure of the steel bars in the joints.

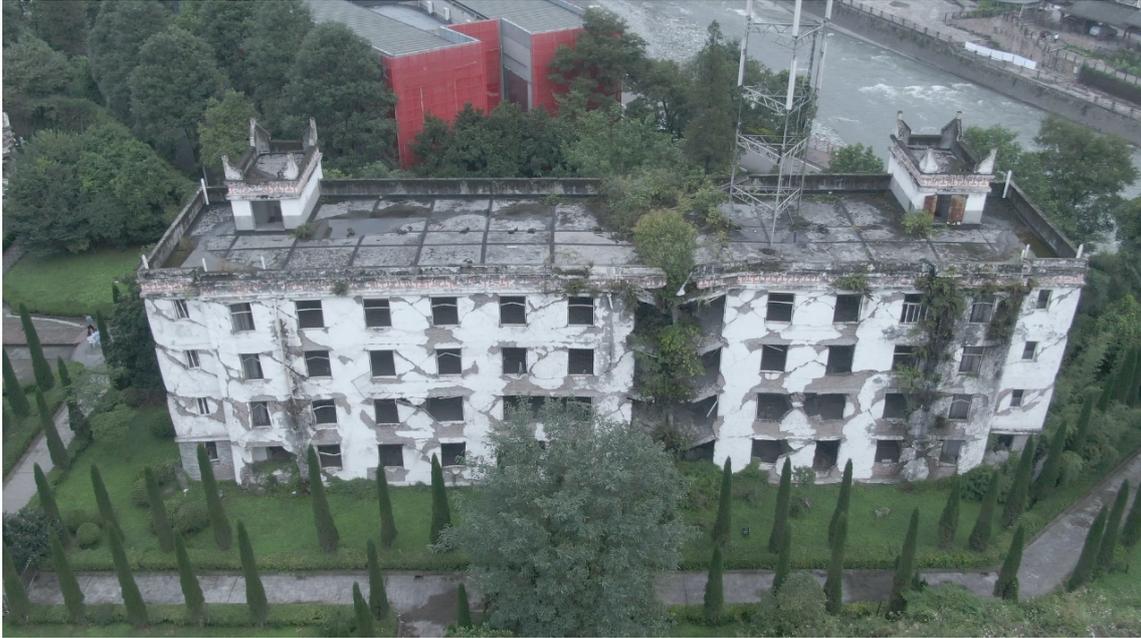
Fig. 17 The earthquake damage of Xuankou middle school students' dormitory

Xuankou middle school students' dormitory had five stories (Fig.17), the underlying had serious damage and cross gable crack that extended to the vertical walls. In the upper stories, the wall under the windows and the wall between windows had cross damage too. The bottom of the vertical wall had serious damage but did not lose the carrying capacity of the structure. Figure 6 was teaching building. In addition, the foundation and the structure had been collapsed. The structure had collapsed with cross wall damage of each storey. The bottom storey had collapsed too, and the weak area in each storey collapsed and lack of storey yield(Fig.18).

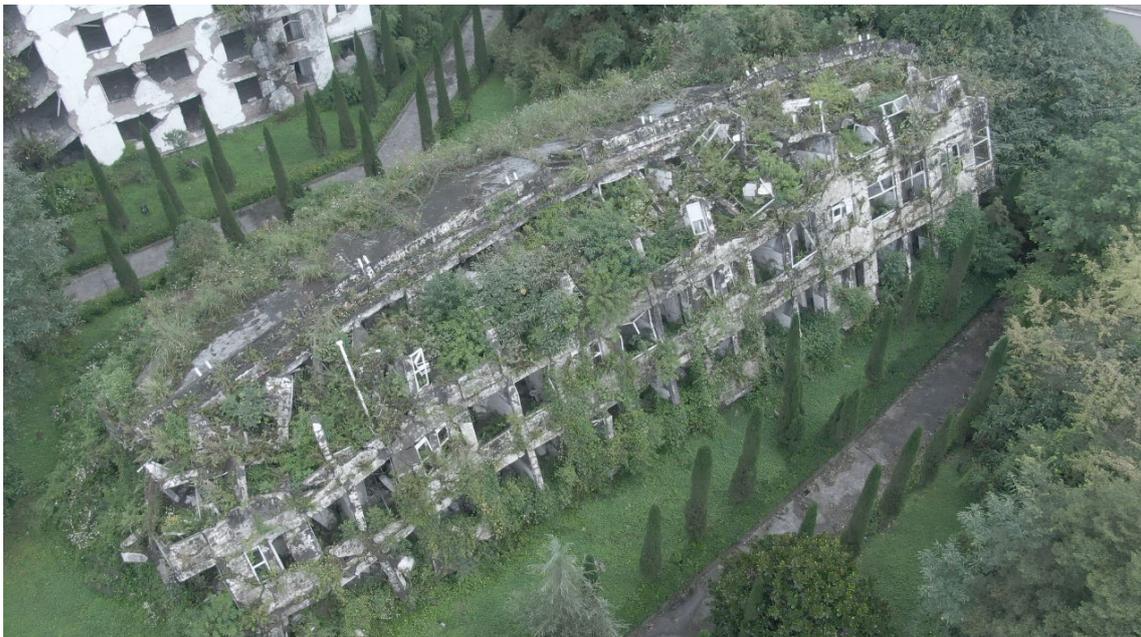
Fig.18 The earthquake damage of Xuankou middle school teaching building.

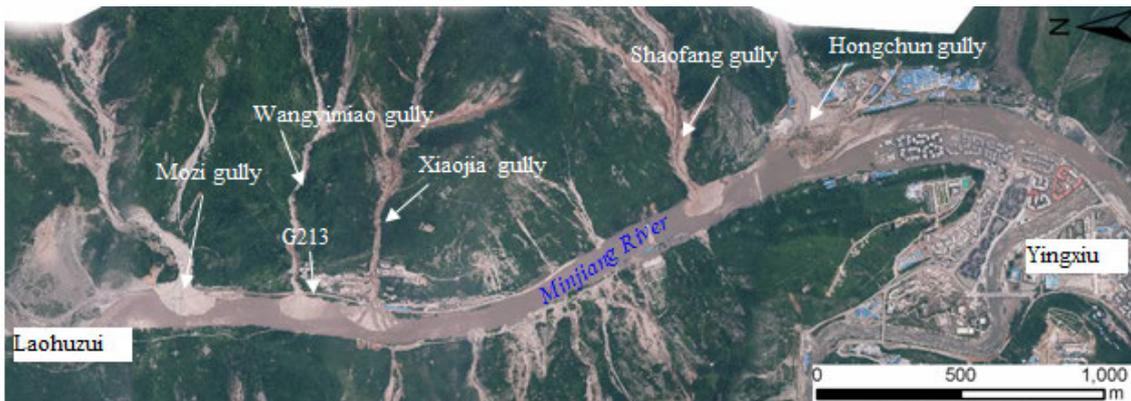
Fig.19 Aerial photo taken on August 15th, 2010 showing the debris flows induced by the August 13th-14th, 2010 heavy rainfall along the Minjiang River (from Yingxiu to Laohuzui)

Since the Wenchuan earthquake in 2008, intense rainfall events have triggered a large number of debris flows (Fig.19), leaving more than 2,000 people dead or missing, and creating many problems during the restoration and reconstruction of the earthquake-affected areas (Wang et al., 2022). The Year 2010 was the most tragic disaster year for debris flows in the Wenchuan-earthquake-affected area (Fig.20). In succession, Yingxiu Town, which was located near the epicenter, suffered serious debris flow disaster and coupled flood event on 14 August 2010 (Xu et al., 2012; Chang et al., 2017).

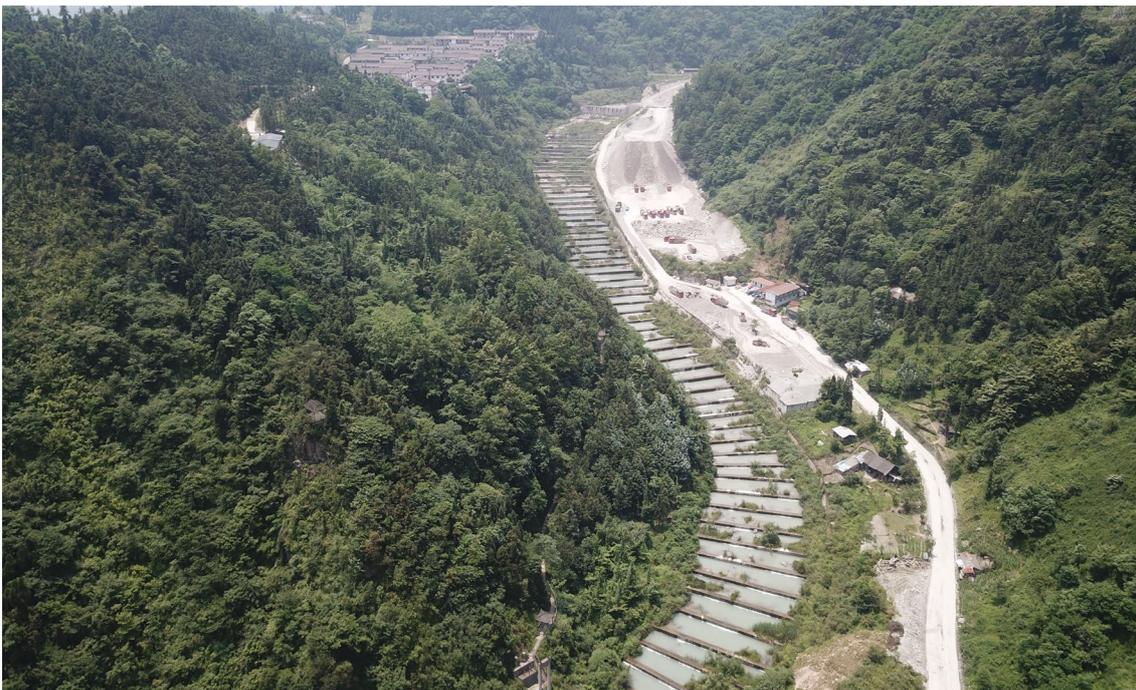
Fig. 22 Drainage channel of Niujuan debris flow

The Niujuan Gully (Fig. 21, Fig. 22) was the epicenter of the "5.12" Wenchuan earthquake. The total length of the valley is 3 km, before the earthquake, a group of 33 villagers in Zhangjiaping Village lived here, the "5.12" Wenchuan earthquake began to tear the earth from here in Niujuan Gully, huge energy to smash the underground rocks, with a terrifying loud noise, millions of cubic meters of rock fragments ejected from the earth's crust, causing strange and terrible rock flows down the valley in a zigzag shape hitting the mountains on both sides of the valley, forming a huge source ejection, nearly 3 km long rock flow and 9 mountains hit such a unique source wonder. Before the Wenchuan earthquake in 2008, Niujuan Gully was a clear water gully. Unfavorable geological phenomena such as collapse and landslides in the basin were not obvious, and only a small volume of loose deposits was observed in the gully, with a total amount of approximately $93.97 \times 104 \text{ m}^3$. After the earthquake,

Niujuan Gully was transformed into a high-frequency debris-flow gully. Adverse geological disasters such as collapses and landslides in the study area affected by the earthquake subsequently strongly developed, with the material source amount caused by collapse and landslide having been estimated as approximately $695.22 \times 10^4 \text{ m}^3$, providing abundant loose solid materials for the occurrence of debris flows (Fan et al., 2019).

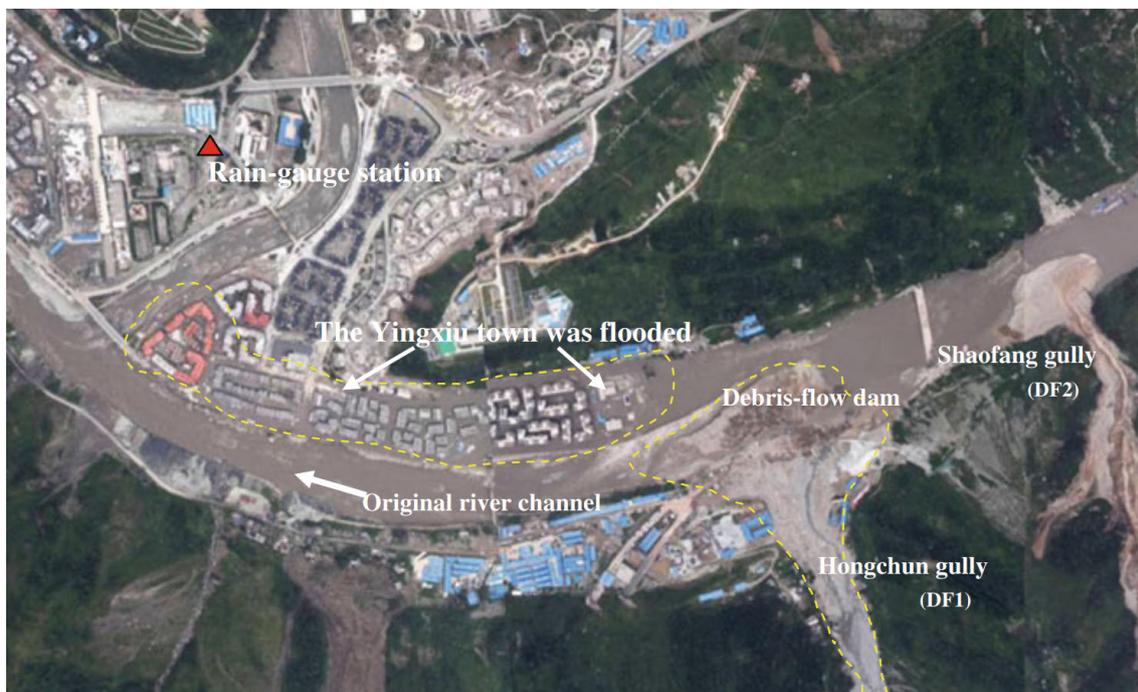
Fig. 23 Aerial photo showing the depositional fan of the Hongchun debris flow (taken on Aug 15th, 2010)

The Hongchun gully (Fig.21) is located on the left bank of the Minjiang River and adjacent to the 2008 Wenchuan earthquake's epicenter. It has a catchment area of 5.35 km² and a height range from 880 m to 1,700 m. The catchment area is an ancient debris flow gully and the total volume of loosely deposited material increased to 350 × 10⁴ m³ after the Wenchuan earthquake. The bedrocks mainly consist of highly fractured and weathered granitic rocks, Sinian pyroclastic rock, Carboniferous limestone, and Triassic sandstone. On August 14, 2010, at 3:00 A.M., triggered by intense rainfall, numerous debris flows occurred near Yingxiu. These flows deposited mud, debris, and rocks onto the G213 national road and the Dujiangyan–Wenchuan highway (at that time under construction), and finally moved down into the Minjiang River (Fig.23). They produced debris dams that entirely or partially blocked the Minjiang River at tributary junctions resulting in severe flooding in Yingxiu. Hongchun Gully, one of these debris flows, produced a huge debris dam, which then changed the course of the Minjiang River and resulted in the flooding of the newly reconstructed Yingxiu Town. The peak discharge of the river increased from 570 m³/s to 1,400 m³/s on August 15th, shortly after the debris flow damming event. The flood depth was 2.0 - 3.5 m and lasted 7 days until the dam was excavated on August 20th, 2010. This catastrophic debris-flow damming event caused 32 fatalities. More than 8,000 residents have been forced to evacuate after the debris flow occurred. To reduce the potential debris flow hazard in the future, control works have been constructed (Fig.24). Prior to this catastrophic event, debris flow hazard had been recognized in the region, but its potential for such widespread and devastating impacts was not fully appreciated.

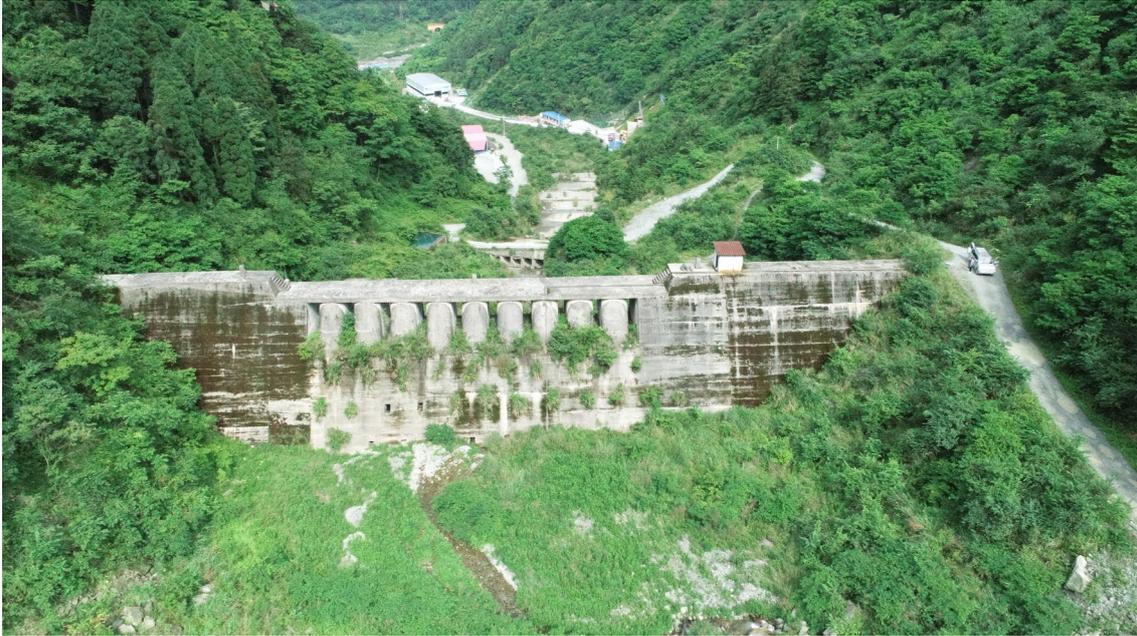
Fig. 24 Check dams constructed in the gully for debris-flow hazard mitigation
